# Model 800

## Disassembly Instructions and Troubleshooting

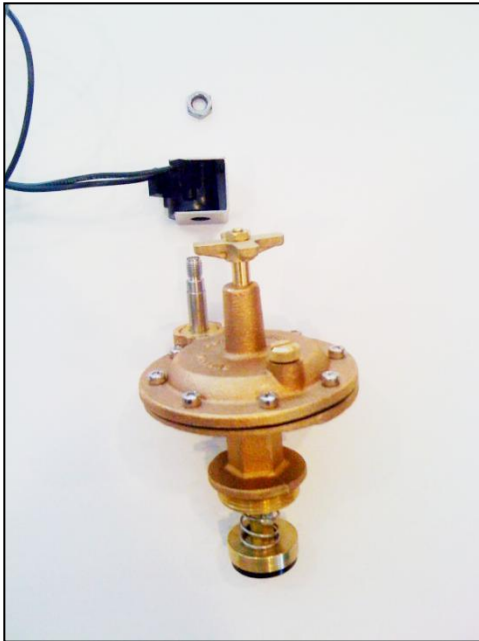
**1.** Unscrew and remove retaining nut from solenoid post and slide coil and U-frame off of solenoid post.

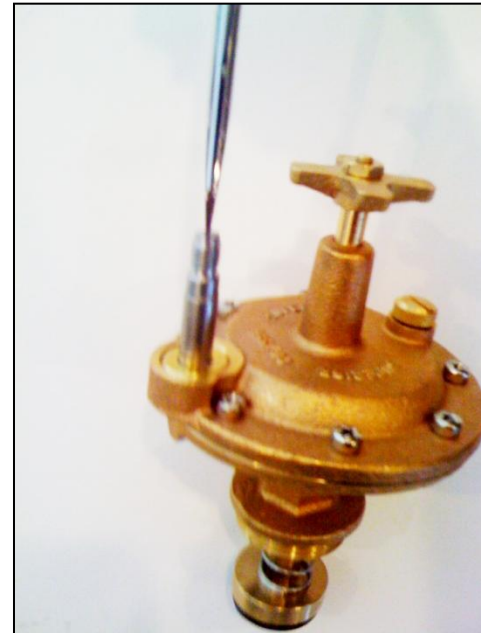
**2.** Using a flathead screwdriver, unscrew and remove solenoid post from top of adaptor.

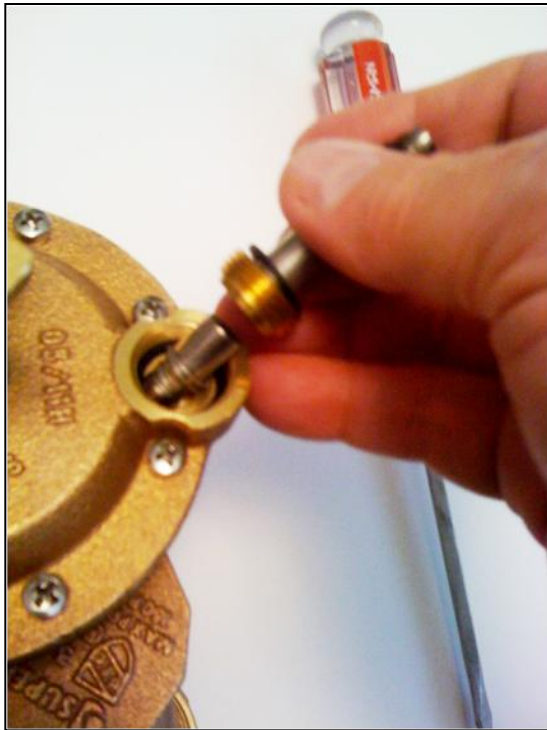
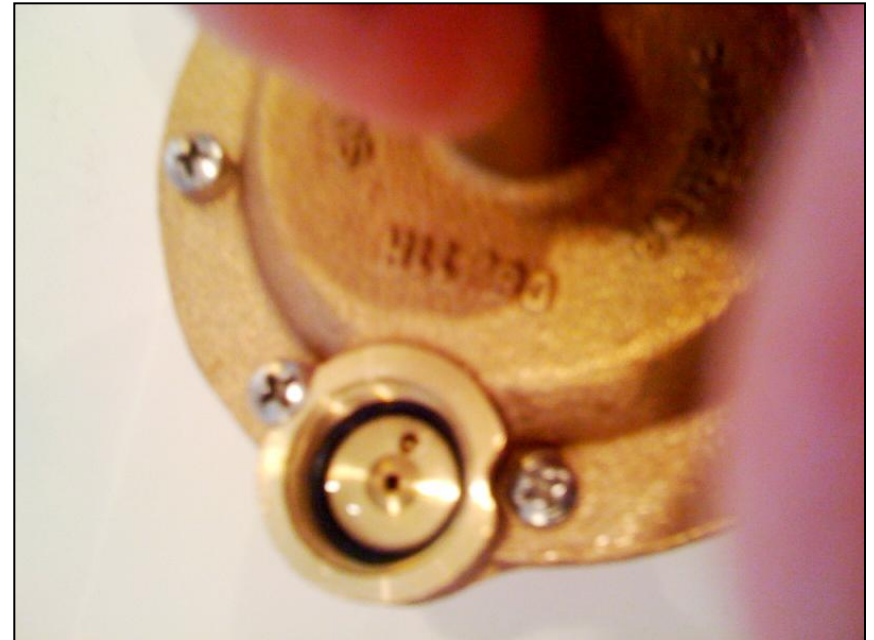
3. Solenoid plunger will drop out of plunger tube as post is removed from solenoid cavity.

Solenoid cavity. The center port is the exhaust port. The other port connects the solenoid cavity to the diaphragm chamber.

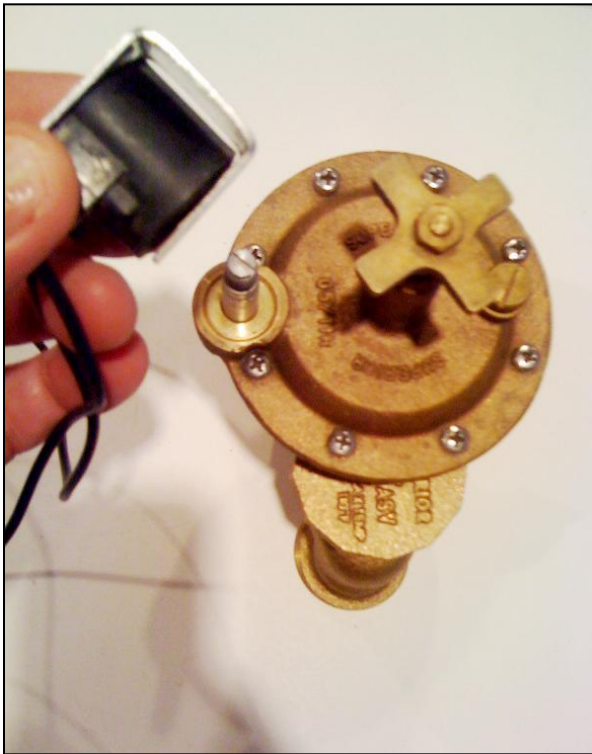
1. After shutting off water supply to the adaptor, remove solenoid retainer nut, coil, and U-frame from solenoid post.

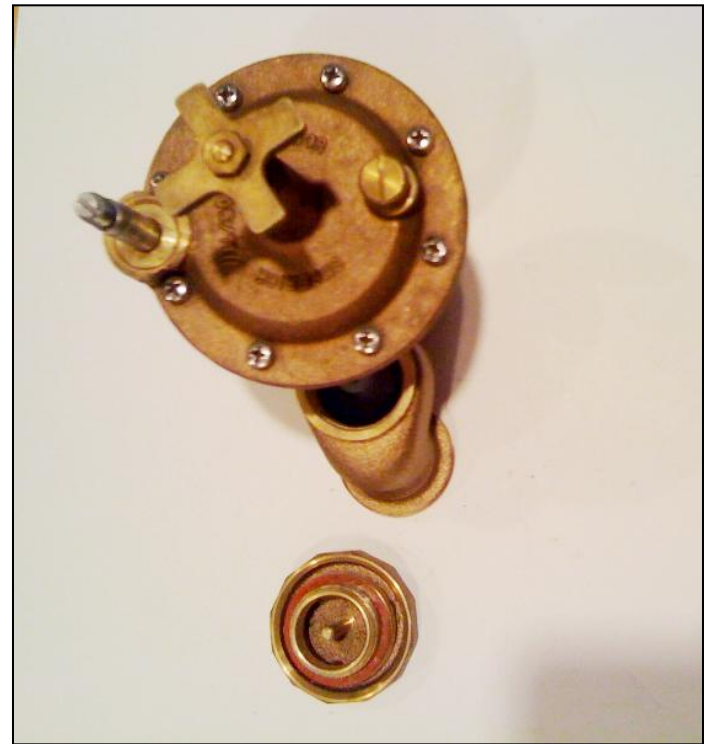
2. Using channel locks, remove anti-siphon cap from valve body.

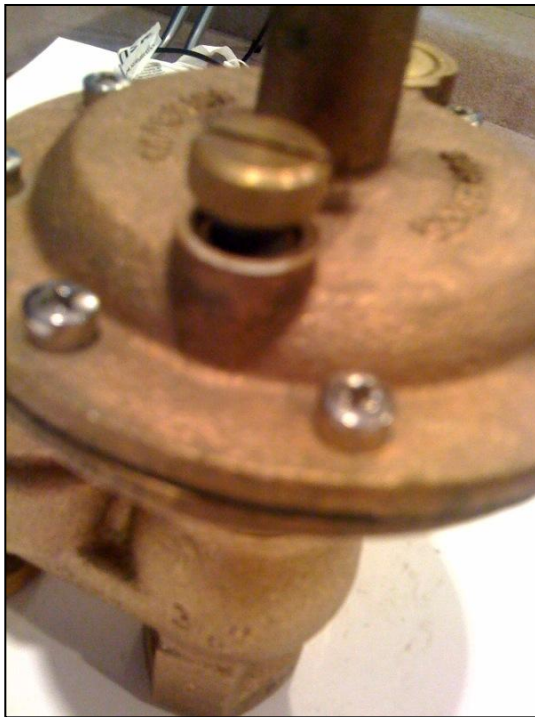
3. Unscrew manual bleeder a few turns to relieve pressure from the top of the diaphragm.

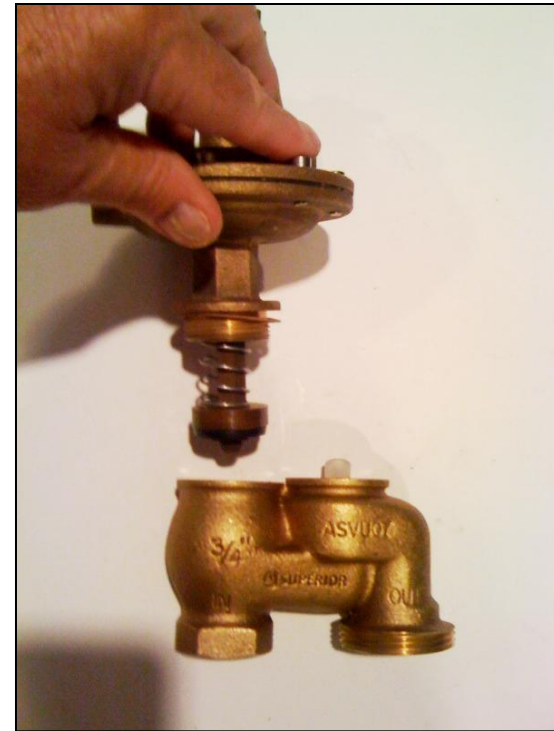
4. Apply a wrench to hex portion (neck) of adaptor and unscrew it from the valve body.

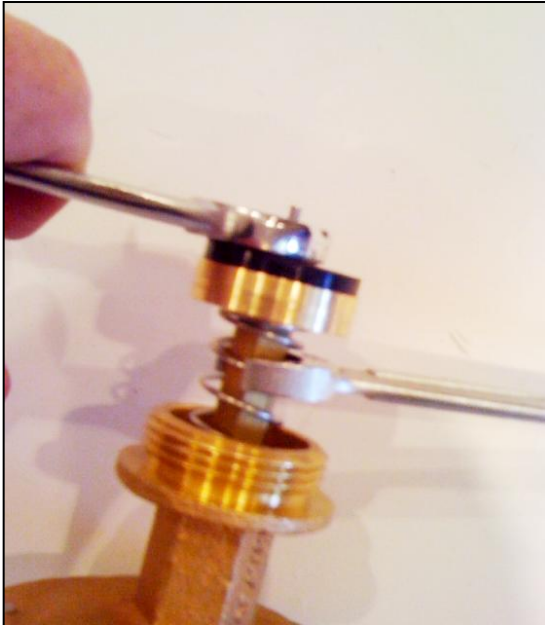
1. Use a 7/16" wrench to apply to shaft and 9/16" wrench to unscrew seat disc retaining nut.

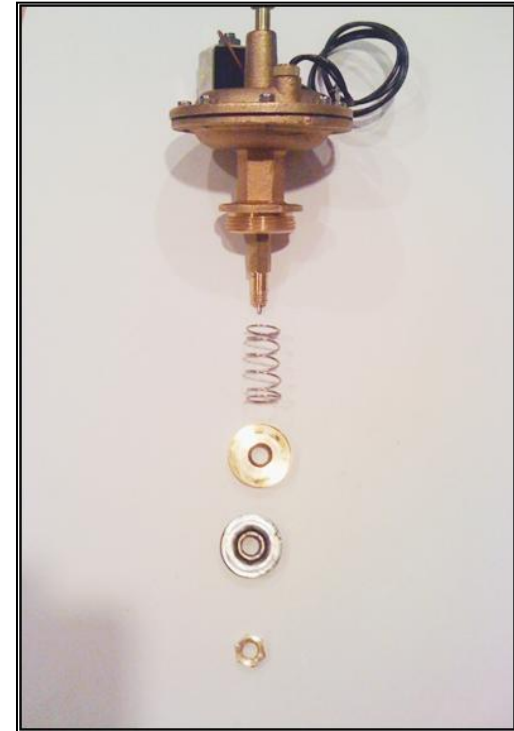
2. Remove seat disc, disc holder and spring from the shaft.

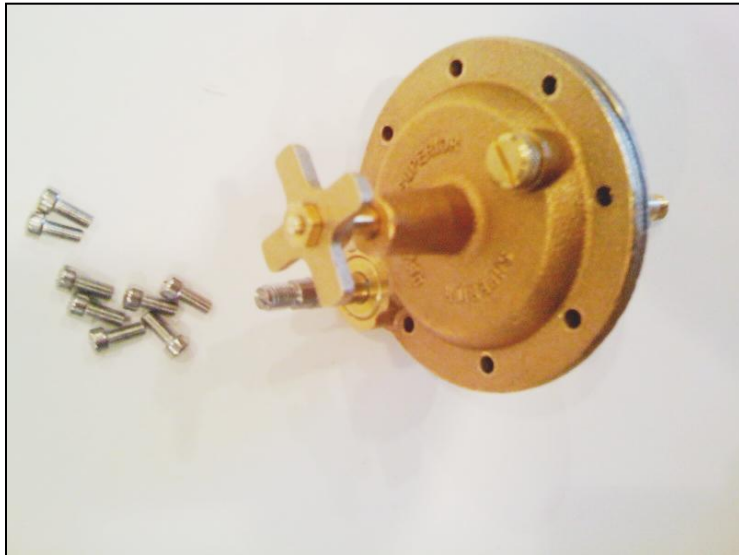
3. Using a Phillips head screwdriver, remove screws from top of adaptor.

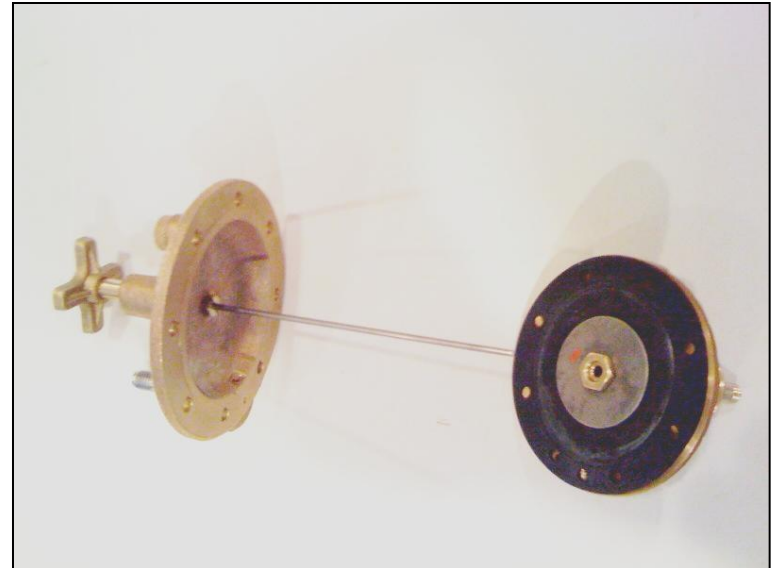
4. Lift top straight up until metering rod clears the top of the diaphragm shaft. It may be necessary to pry the top loose from lower housing using a flathead screwdriver.

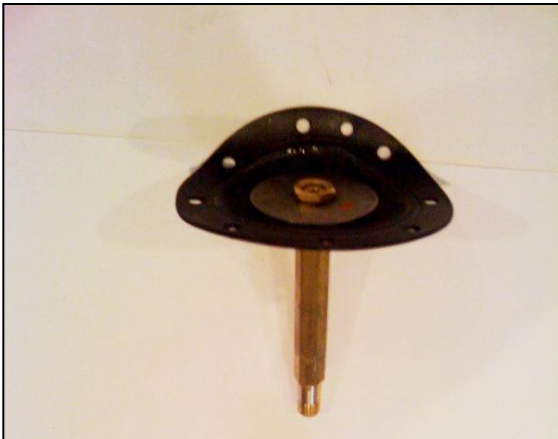
5. Lift and remove diaphragm assembly from lower diaphragm housing.

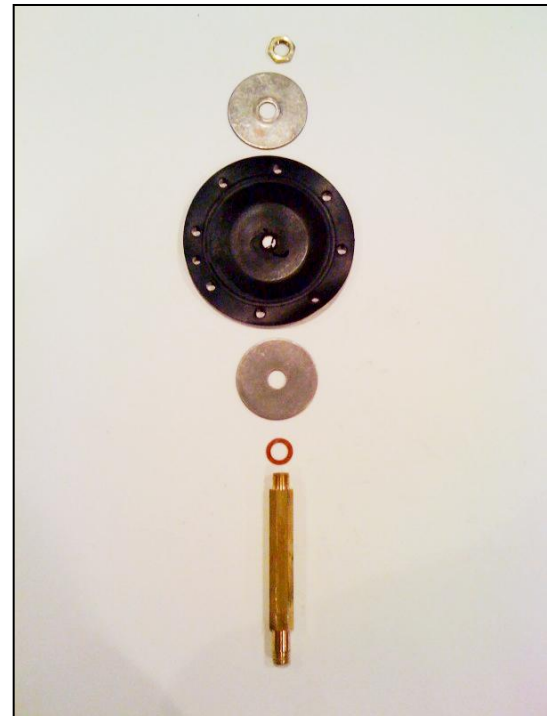
6. To disassemble diaphragm assembly, use a 7/16" wrench to hold shaft, and 9/16" wrench to remove nut at top of diaphragm shaft.

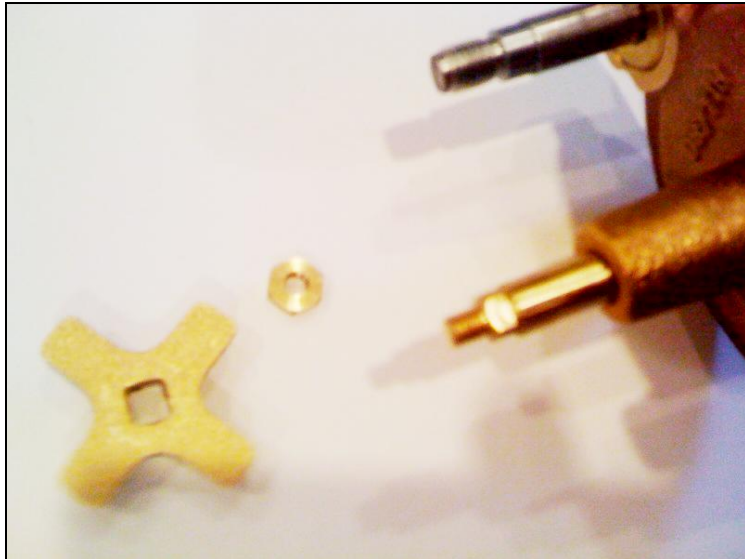
**7.** To remove flow control stem from top of adaptor, first remove the nut and cross-handle from top of stem.

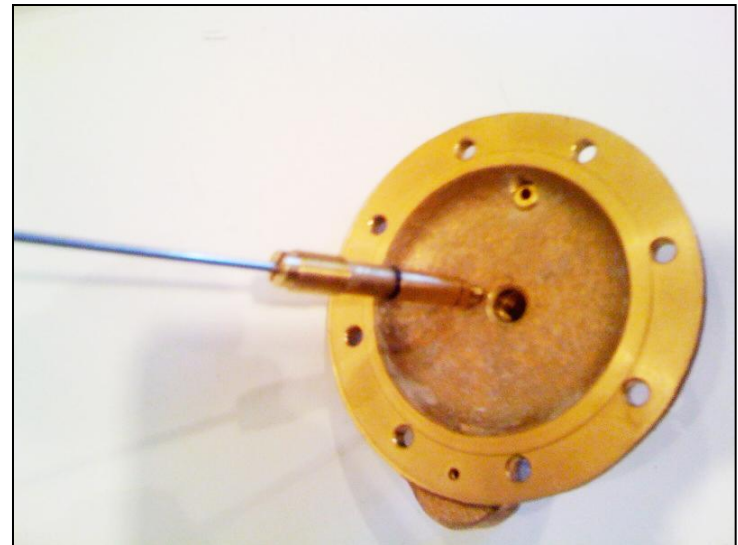
**8.** Unscrew flow control stem from under side of top.

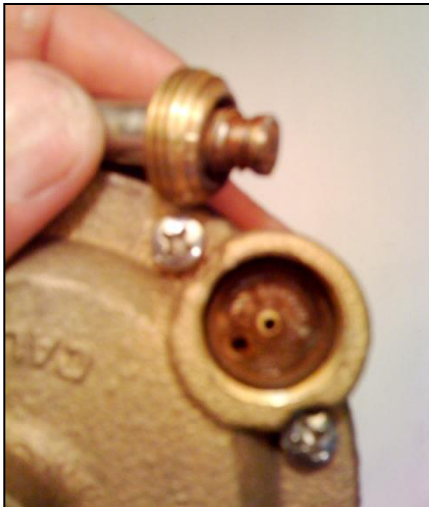
**PROBLEM:** Valve will not close.

**CAUSE #1:** Malfunctioning solenoid. Solenoid plunger is unable to seal exhaust port due to debris in solenoid chamber or plunger being stuck in plunger tube and unable to drop.

**SOLUTION:** Remove debris from solenoid cavity and/or clean plunger tube. Replace stem and plunger assembly if necessary.

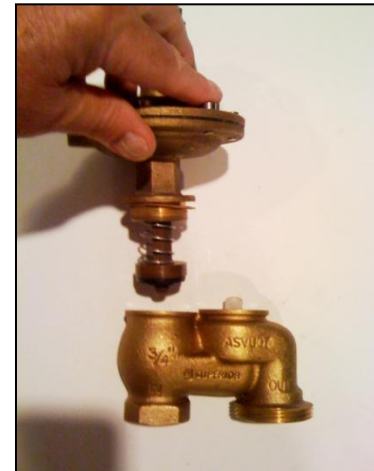
**PROBLEM:** Valve will not close.

**CAUSE #2:** Debris in valve body prevents rubber seat disc from seating onto brass seat in anti-siphon body.

**SOLUTION:** Remove adaptor from anti-siphon body and remove debris. If rubber seat disc is pitted, disassemble it from shaft and flip it over or replace if necessary.

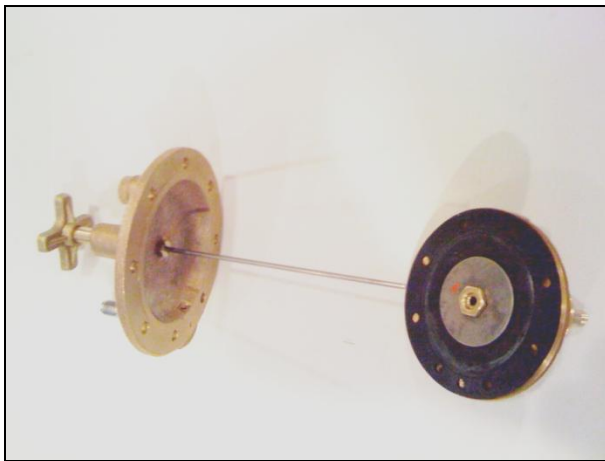
**PROBLEM:** Valve will not close.

**CAUSE #3:** Open manual bleeder. If no water exhausts from manual bleeder, the likely cause is a buildup of minerals on the metering rod that is preventing water from entering the diaphragm chamber.

**SOLUTION:** Remove top of adaptor and clean the metering rod using emery cloth

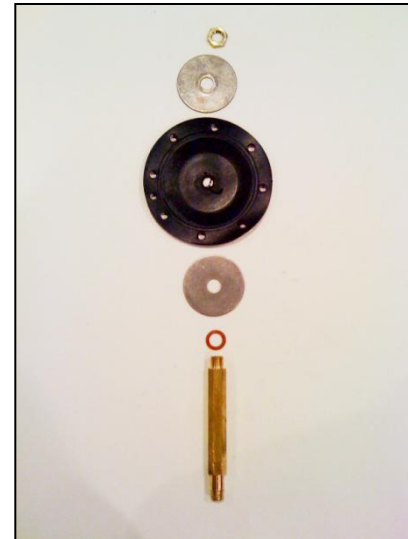
**PROBLEM:** Valve will not close.

**CAUSE #4:** Torn Diaphragm.

**SOLUTION:** Disassemble valve and replace diaphragm .

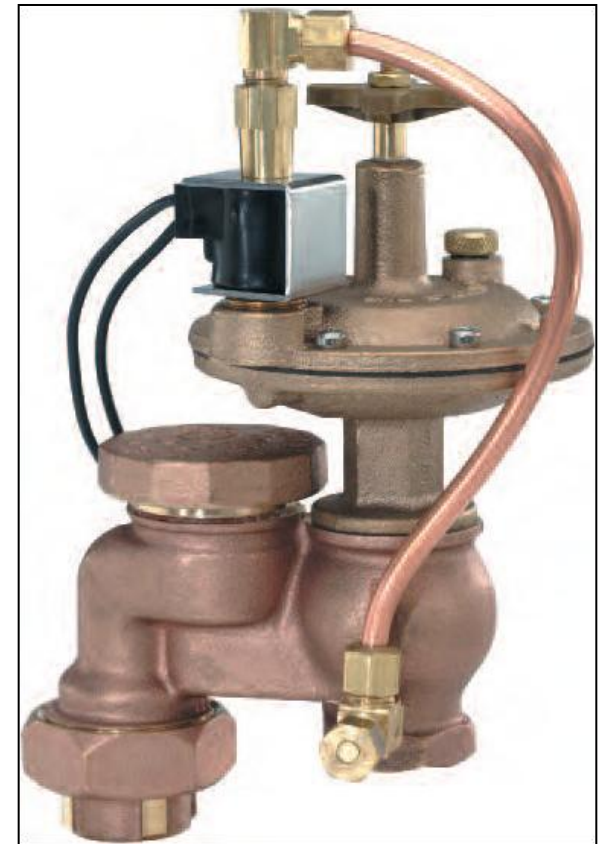
**PROBLEM:** Valve will not close.

**CAUSE #5:** Insufficient flow. Irrigation valves and adaptors have a minimum flow requirement in order to close. The larger the valve size, the greater the minimum flow requirement. A  $\frac{3}{4}$ " 800 adaptor has a minimum flow requirement of about 5 GPM.

**SOLUTION:** Sometimes, reducing the flow by turning the flow control handle clockwise as much as possible without adversely affecting coverage will enable the valve to close. If it works, do not readjust the flow control. If it does not work, then increase flow by adding sprinkler heads or emitters to the system. If that is not possible, then it is recommended that a model 850-DI be used in place of the model 800. This will necessitate replacing the anti-siphon valve body as well. The model 850-DI, shown in photo at right, has no minimum flow requirement. It was designed to be used in low flow drip irrigation systems.

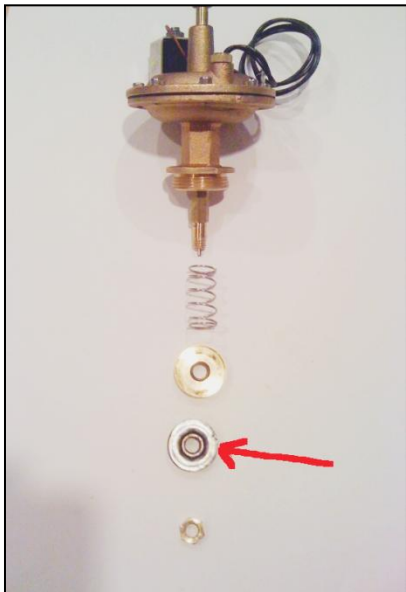
**PROBLEM:** Water weeps past the valve and seeps out of the lowest head.

**CAUSE #1:** Small debris under rubber seat disc or pitted rubber seat disc.

**SOLUTION:** Remove adaptor from anti-siphon body and clean debris. If the rubber seat disc is pitted, remove it, flip it over and reassemble, or replace seat disc.

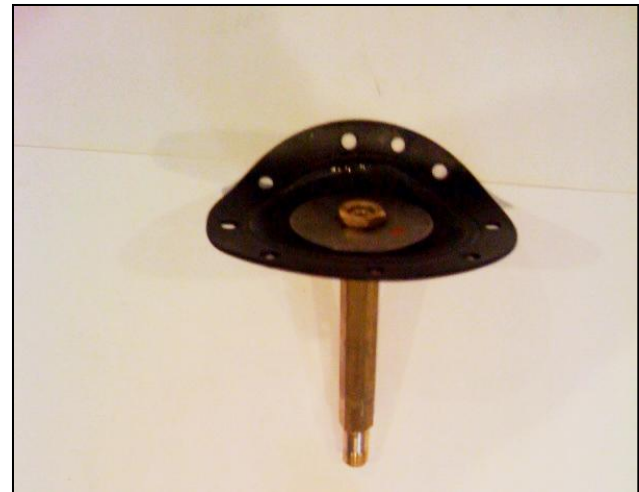
**PROBLEM:** Water weeps past the valve and seeps out of the lowest head.

**CAUSE #2:** If there is no evidence of debris or pits in the rubber seat disc, the likely cause is that the nut at top of diaphragm assembly is loose allowing water to seep past the threads of the diaphragm shaft. This eventually causes the threads to erode and the problem becomes worse over time.

**SOLUTION:** Replace diaphragm assembly or replace adaptor.

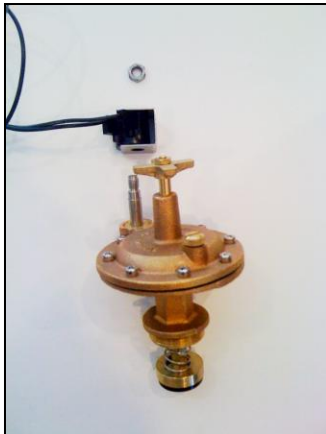
**PROBLEM:** Valve will not open when energized.

**CAUSE #1:** Solenoid is not receiving power.

**SOLUTION:** Place your fingers around the solenoid coil to see if it is receiving power. There should be a slight vibration and humming. If not, verify that there is output at the controller by using a volt meter. If there is electrical output (24 VAC) then the problem is either a bad coil or broken wire. Check the coil by disconnecting solenoid lead wires from valve wires and measure ohms with an ohm meter. A reading of 24 to 27 ohms means the coil is OK. If reading is 0 or infinity, replace coil.

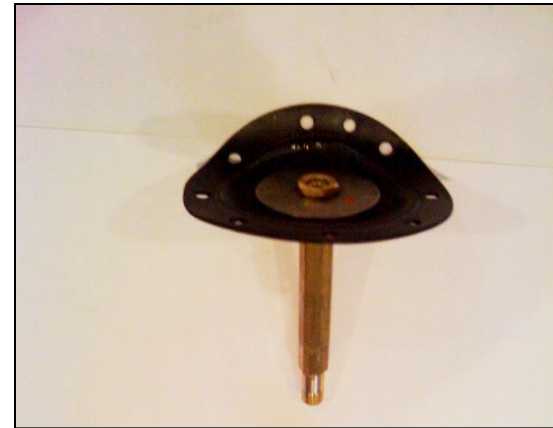
**PROBLEM:** Valve does not open or only opens part way when energized.

**CAUSE #2:** Enlarged inlet orifice at bottom of diaphragm shaft is allowing water to enter diaphragm chamber at a rate greater than it can exit through solenoid exhaust port. Because the inlet orifice is brass, it can enlarge over time in high pressure/velocity conditions.

**SOLUTION:** Replace diaphragm assembly (which includes diaphragm shaft) or replace adaptor.

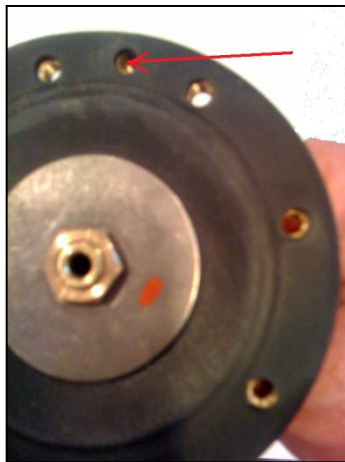
**PROBLEM:** Valve will not open when energized.

**CAUSE #3:** If adaptor was recently taken apart and reassembled, it is possible that the diaphragm was not aligned properly. There are nine holes in the outer ring of the diaphragm, one for each screw hole plus one that lines up with the solenoid exhaust port. If that ninth hole is not positioned over the exhaust port, the valve will not open electrically.

**SOLUTION:** Realign diaphragm properly.

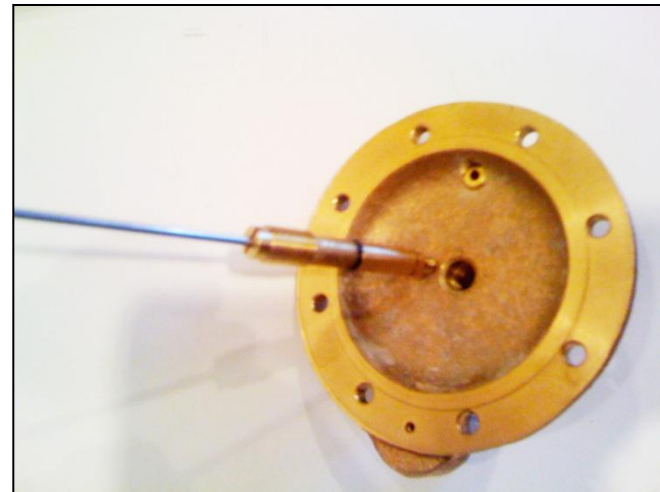
**PROBLEM:** Water leaks out of top of adaptor where flow control stem protrudes from top housing.

**CAUSE:** Damaged flow control o-ring.

**SOLUTION:** Remove nut and flow control cross-handle, then unscrew flow control stem from the under side of the top. Replace o-ring. Apply silicone grease to the o-ring before reassembling it into the top.

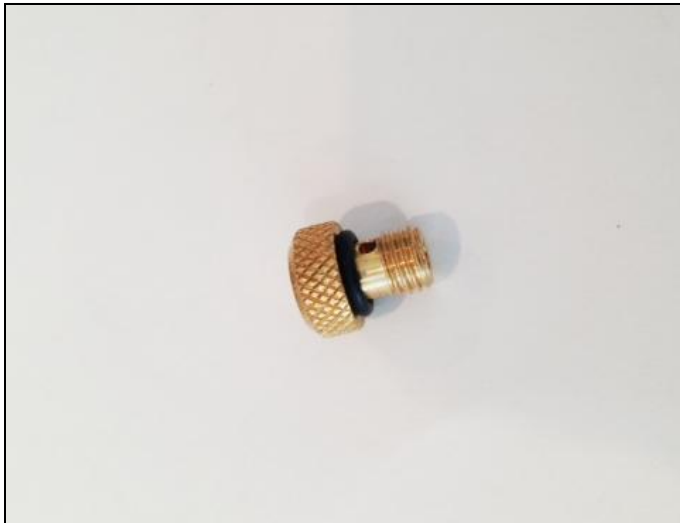
**PROBLEM:** Water leaks out around manual bleed screw.

**CAUSE #1:** Damaged o-ring on bleed screw.

**SOLUTION:** Replace bleed screw.

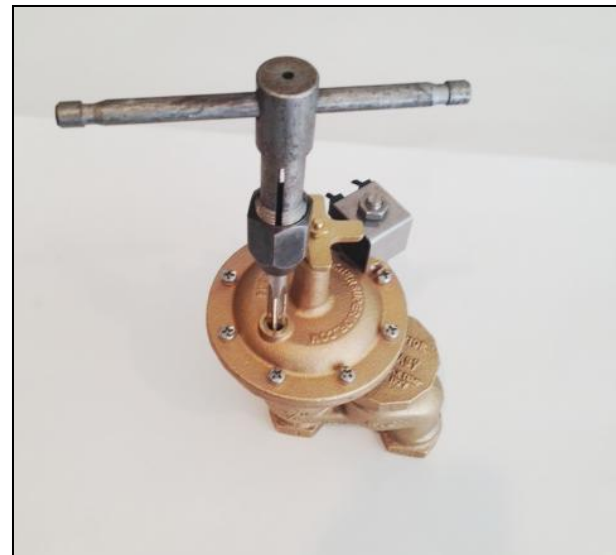
**PROBLEM:** Water leaks out around manual bleed screw.

**CAUSE #2:** Bleed screw cannot be screwed all the way down due to disappearing threads in opening. This is caused by a transfer of metal from threads on bleed screw to female threads in opening.

**SOLUTION:** Using a 5/16"-24 tap, rethread opening and replace bleed screw with a new one.

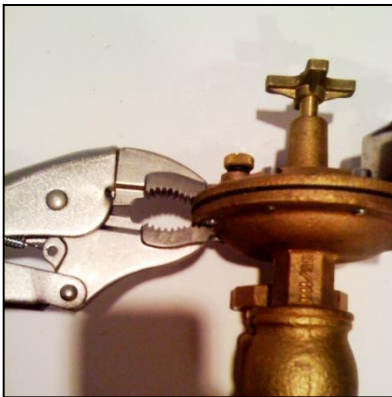
**PROBLEM:** Water leaks out of adaptor between top and lower section and tightening top screws does not stop leakage.

**CAUSE:** Freezing temperatures. Water expands when turning to ice and causes scalloping of top casting particularly in old adaptors with metal fatigue.

**SOLUTION:** Place vice grips between two of top screws and squeeze top and bottom together then tighten screws on both sides of vice grips. Repeat process between all other screws.

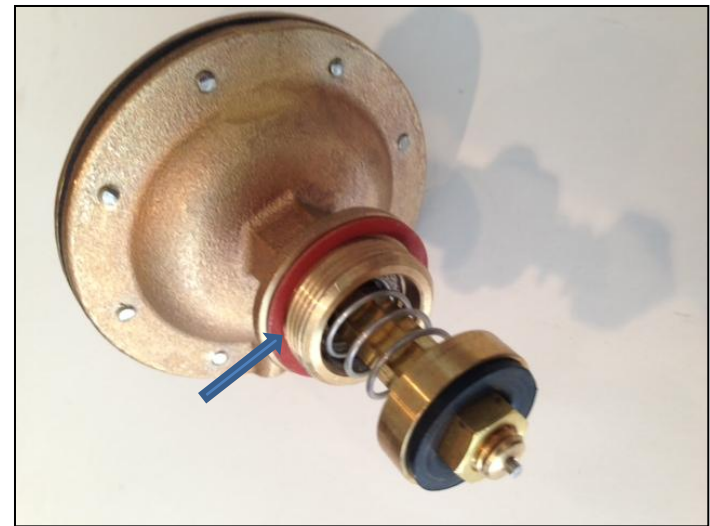
**PROBLEM:** Water leaks out between adaptor and anti-siphon body.

**CAUSE:** Damaged fiber body washer.

**SOLUTION:** Replace damaged fiber body washer.
