SUPERIOR

Model 2000

Disassembly Instructions and
Troubleshooting

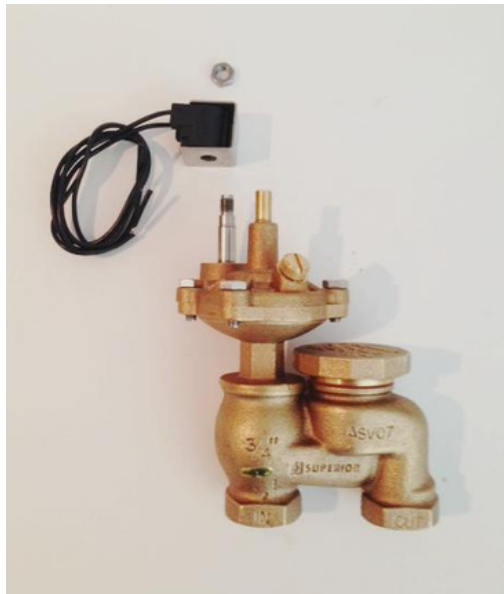
1. Unscrew and remove retaining nut from solenoid post and slide coil and U-frame off of solenoid post.

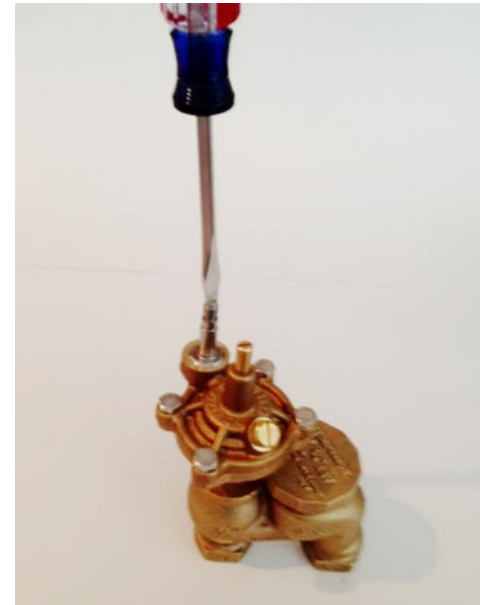
2. Using a flathead screwdriver, unscrew and remove solenoid post from top of adaptor.

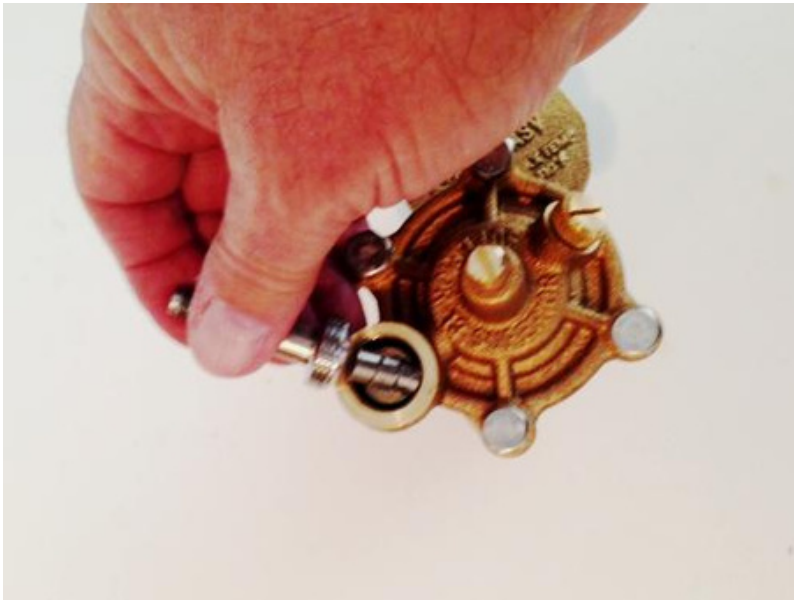
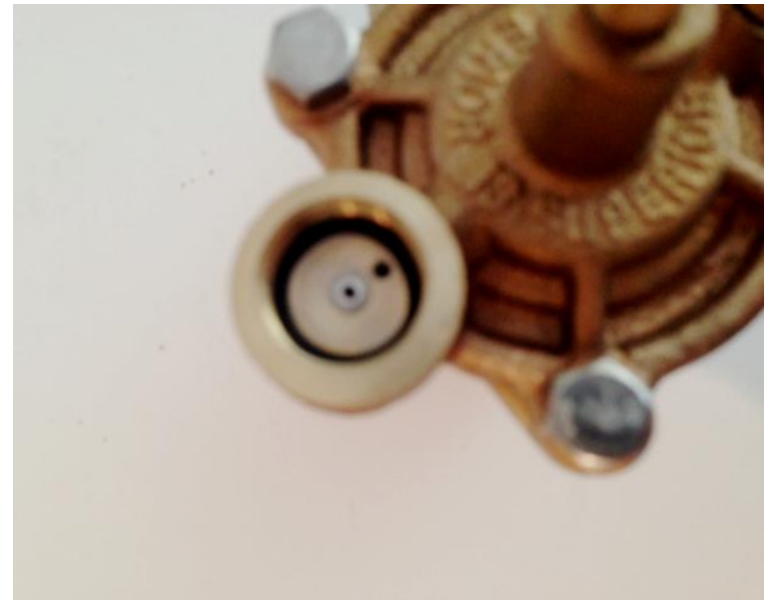
3. Solenoid plunger will drop out of plunger tube as post is removed from solenoid cavity.

Solenoid cavity: The center port is the exhaust port. The other port connects the solenoid cavity to the diaphragm chamber.

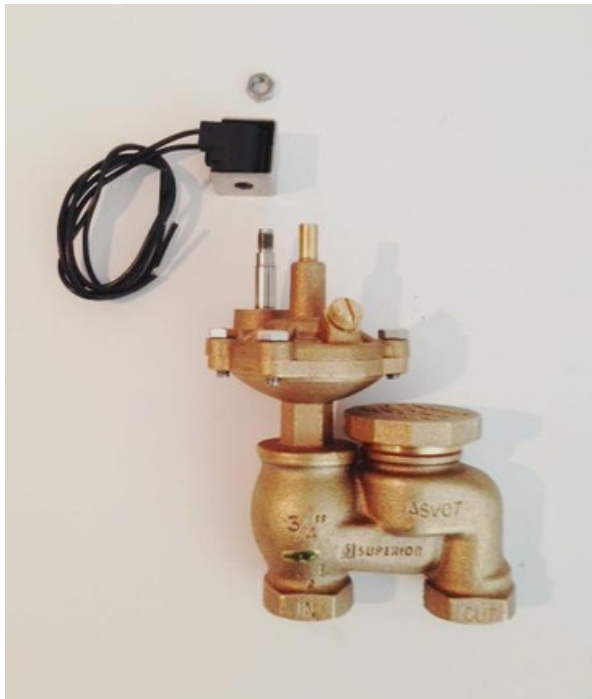
1. After shutting off water supply to the adaptor, remove solenoid retainer nut, coil, and U-frame from solenoid post.

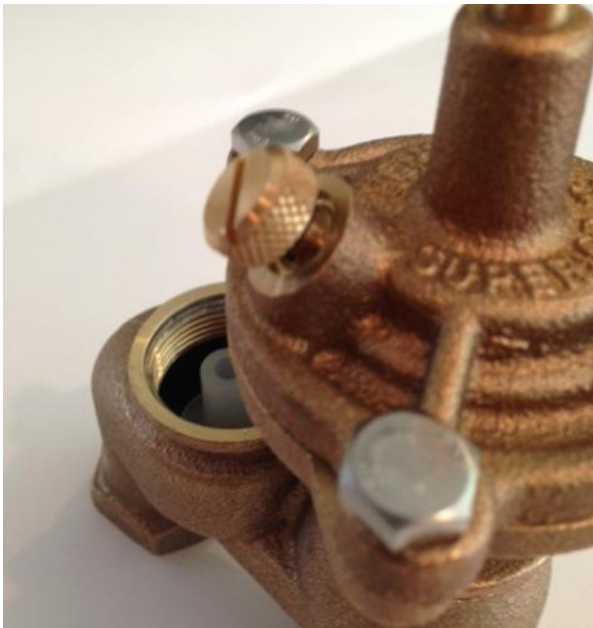
3. Unscrew manual bleeder a few turns to relieve pressure from the top of the diaphragm.

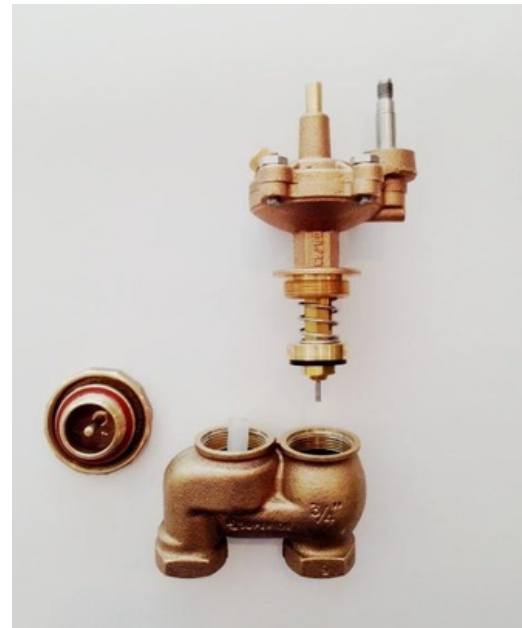
4. Apply a wrench to hex portion (neck) of adaptor and unscrew it from the valve body.

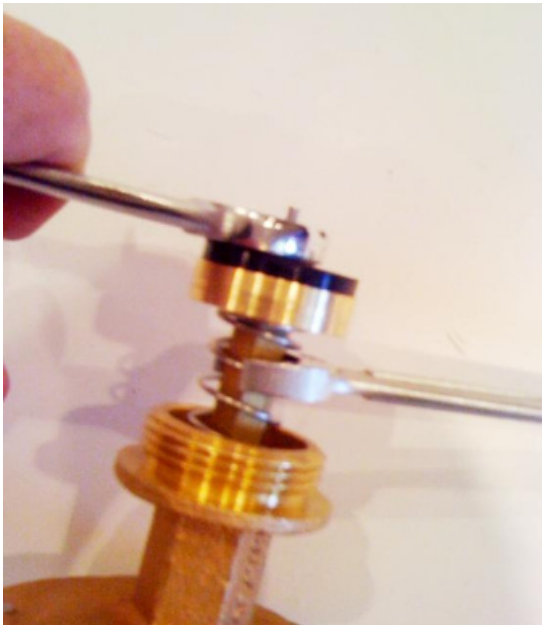
1. Use a 7/16" wrench to apply to shaft and 9/16" wrench to unscrew seat disc retaining nut.

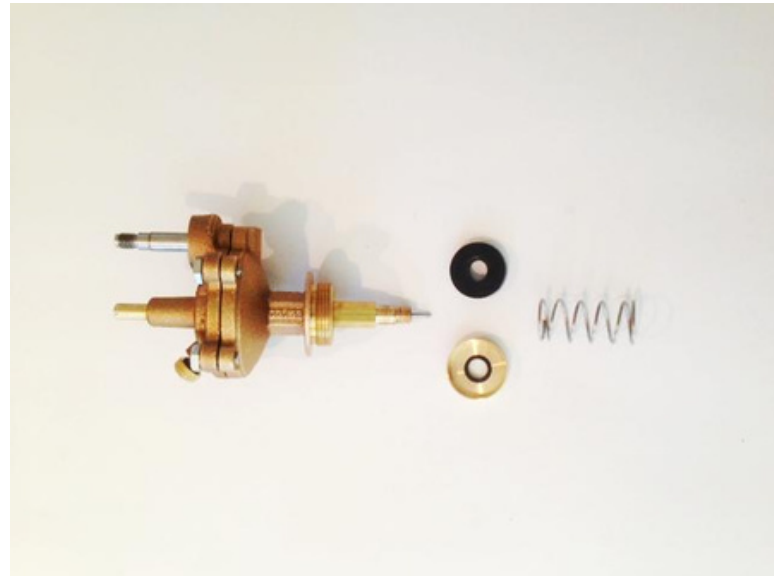
2. Remove seat disc, disc holder and spring from the shaft.

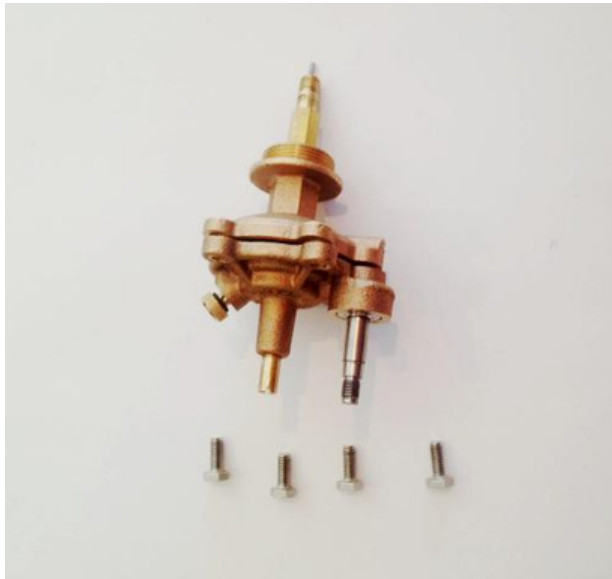
3. Using a 7/16" wrench, remove bolts from top of adaptor.

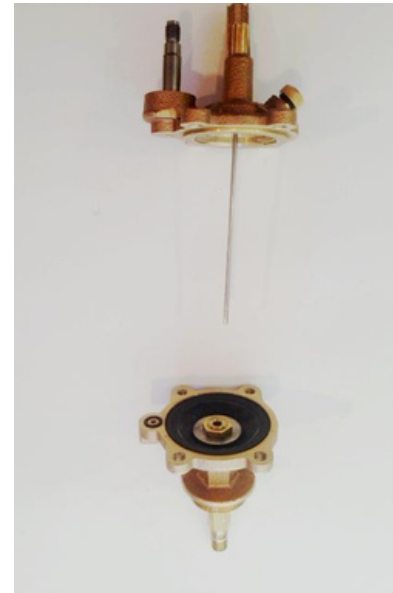
4. Lift top straight up until metering rod clears the top of the diaphragm shaft. It may be necessary to pry the top loose from lower housing using a flathead screwdriver.

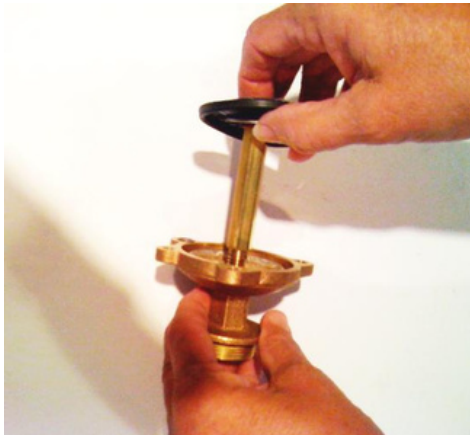
5. Lift and remove diaphragm assembly from lower diaphragm housing.

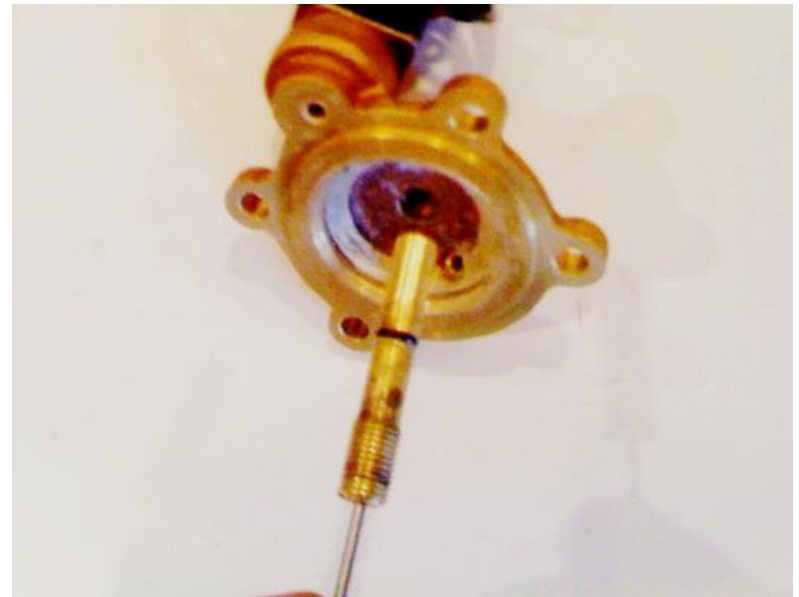
7. To remove flow control stem from top, first use a flathead screwdriver to turn the flow control stem as many turns as possible in clockwise direction. Next, unscrew the flow- control stem from the underside of the top.

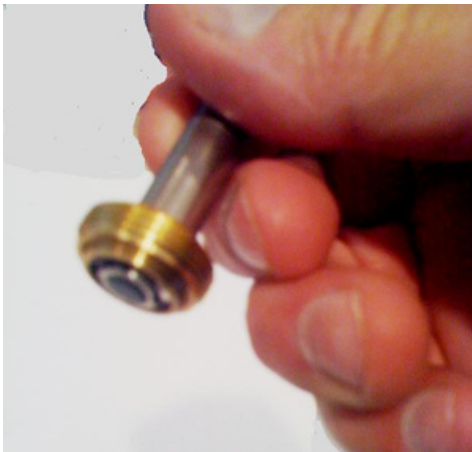
CAUSE #1: Malfunctioning solenoid

Solenoid plunger is unable to seal exhaust port due to debris in solenoid chamber or plunger being stuck in plunger tube and unable to drop.

Remove debris from solenoid cavity and/or clean plunger tube. Replace stem and plunger assembly if necessary.

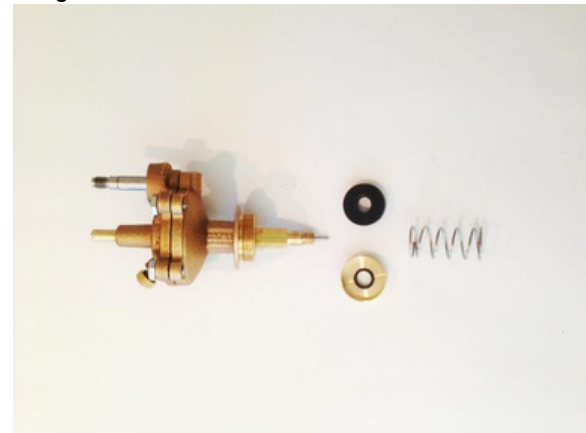
Debris in valve body or debris embedded in rubber seat disc prevents rubber seat disc from seating onto brass seat in anti-siphon body.

Remove adaptor from anti-siphon body and remove debris. If rubber seat disc is pitted, disassemble it from shaft and flip it over or replace if necessary.

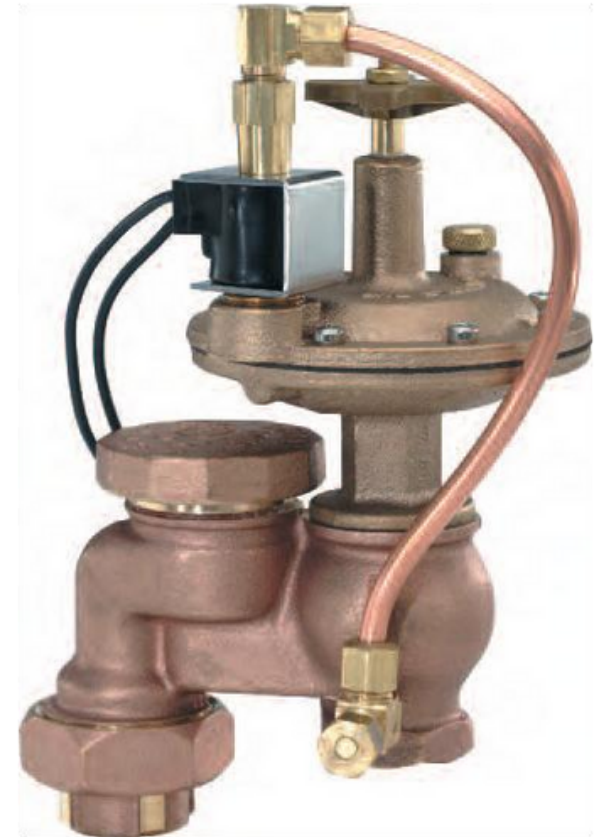
CAUSE #5: Insufficient flow

Irrigation valves and adaptors have a minimum flow requirement in order to close. The larger the valve size, the greater the minimum flow requirement. A $\frac{3}{4}$ " 2000 adaptor has a minimum flow requirement of about 5 GPM

Sometimes, reducing the flow by turning the flow control stem clockwise as much as possible without adversely affecting coverage will enable the valve to close. If it works, do not readjust the flow control. If it does not work, then increase flow by adding sprinkler heads or emitters to the system. If that is not possible, then it is recommended that a model 850-DI be used in place of the model 2000. This will necessitate replacing the anti-siphon valve body as well. The model 850-DI, shown in photo at right, has no minimum flow requirement. It was designed to be used in low flow drip irrigation systems.

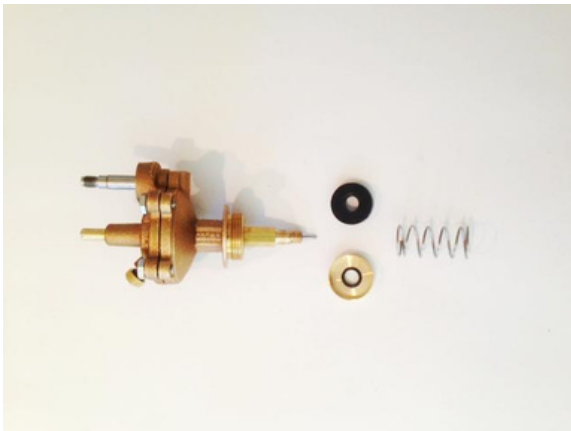
Small debris under rubber seat disc or pitted rubber seat disc.

Remove adaptor from anti-siphon body and clean debris. If the rubber seat disc is pitted, remove it, flip it over and reassemble, or replace seat disc.

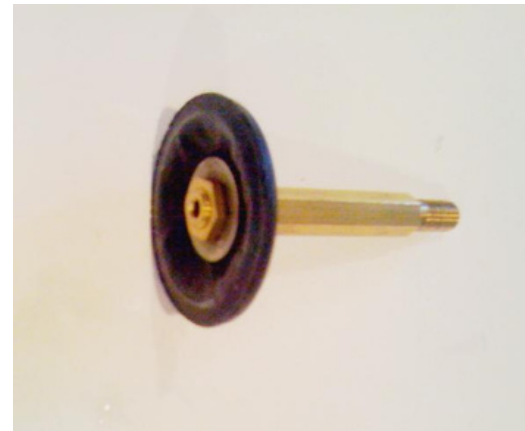
If there is no evidence of debris or pits in the rubber seat disc, the likely cause is that the nut at top of diaphragm assembly is loose allowing water to seep past the threads of the diaphragm shaft. This eventually causes the threads to erode and the problem becomes worse over time.

Replace diaphragm assembly or replace adaptor.

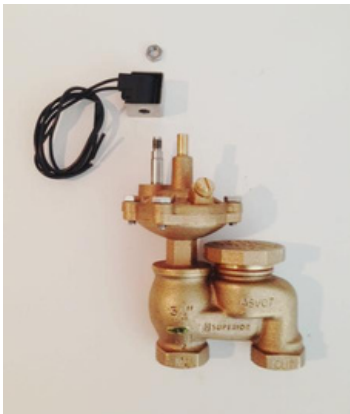
Solenoid is not receiving power

Place your fingers around the solenoid coil to see if it is receiving power. There should be a slight vibration and humming. If not, verify that there is output at the controller by using a volt meter. If there is electrical output (24 VAC) then the problem is either a bad coil or broken wire. Check the coil by disconnecting solenoid lead wires from valve wires and measure ohms with an ohm meter. A reading of 24 to 27 ohms means the coil is OK. If reading is 0 or infinity, replace coil.

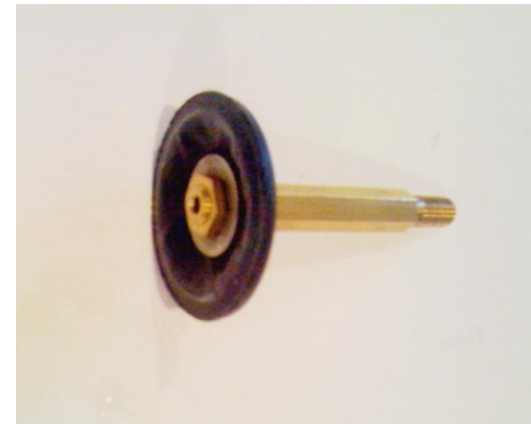
Enlarged inlet orifice at bottom of diaphragm shaft is allowing water to enter diaphragm chamber at a rate greater than it can exit through solenoid exhaust port. Because the inlet orifice is brass, it can enlarge over time in high pressure/velocity conditions.

Replace diaphragm assembly (which includes diaphragm shaft) or replace adaptor.

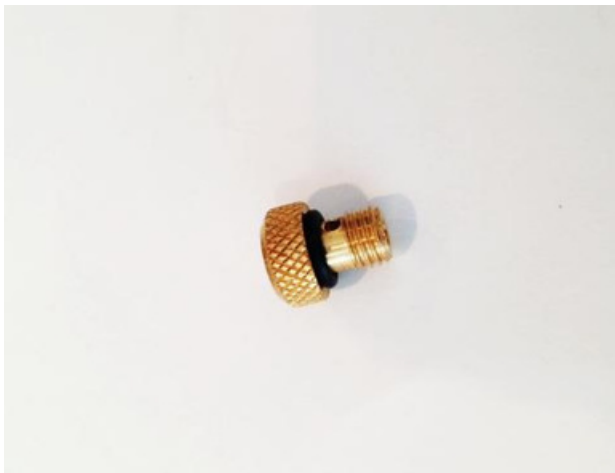
Damaged o-ring on bleed screw.

Replace bleed screw.

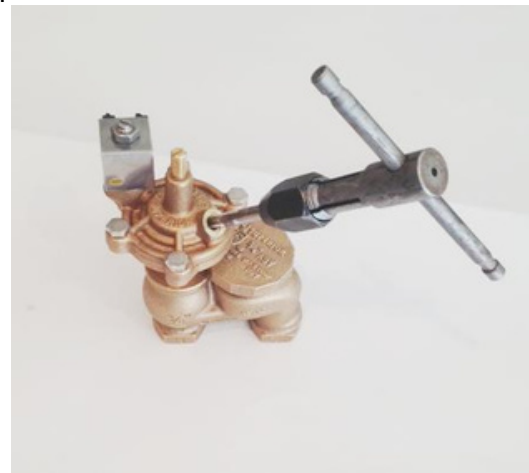
Bleed screw cannot be screwed all the way down due to disappearing threads in opening.

This is caused by a transfer of metal from threads on bleed screw to female threads in opening.

Using a 5/6"-24 tap, rethread opening and replace bleed screw with a new one.

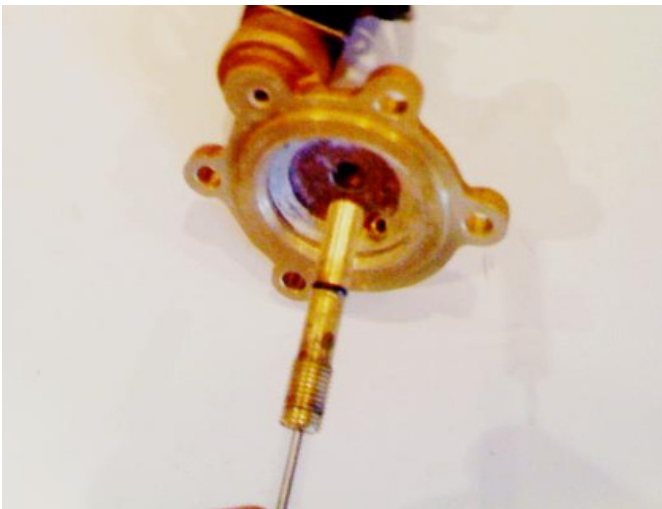
Damaged o-ring on the flow-control stem.

Remove flow-control stem from bonnet and replace o-ring. Apply silicone grease to the o-ring before re-assembling it into the bonnet.

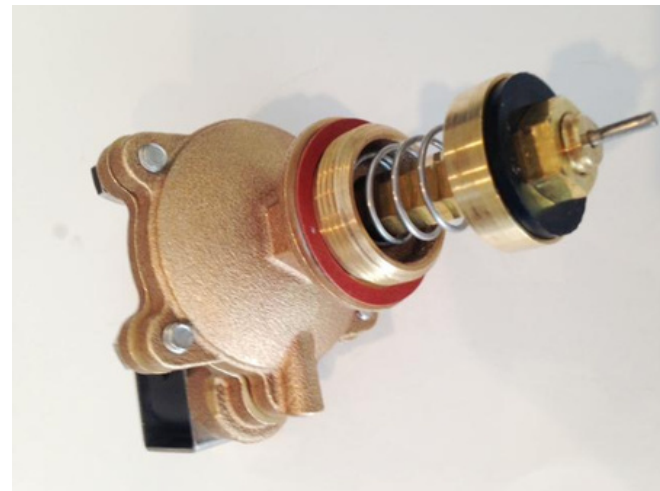
Damaged body fiber washer.

Replace damaged fiber body washer
