SUPERIOR

Model 3300

Disassembly instructions and
Troubleshooting

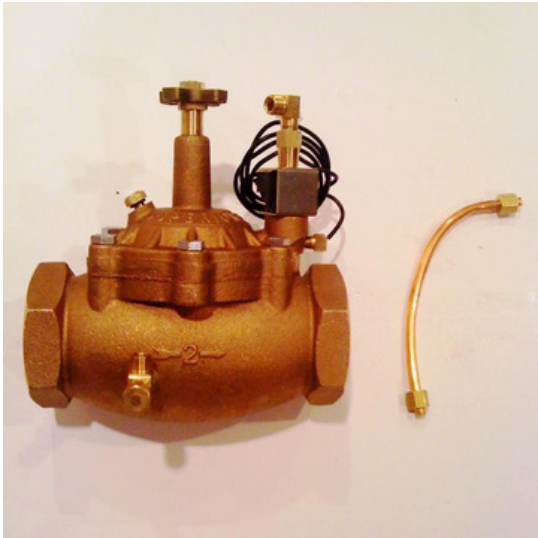
1. Using a $\frac{1}{2}$ " wrench, remove copper tubing that connects T-filter assembly to L-fitting above solenoid.

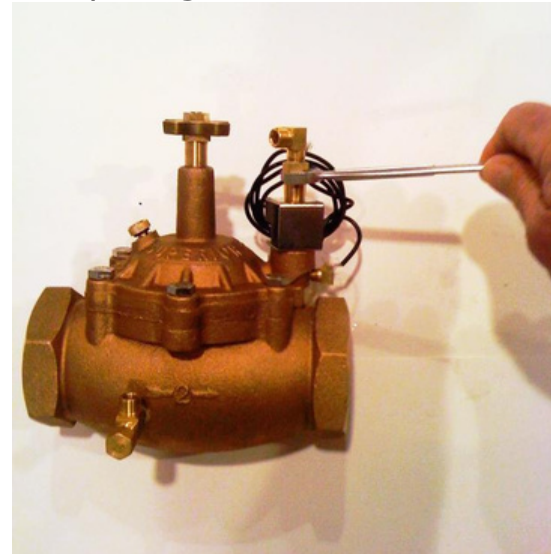
2. Apply $\frac{1}{2}$ " wrench to coupling that connects solenoid post to L-fitting and unscrew coupling and L-fitting from solenoid post. It is not necessary to remove L fitting from coupling.

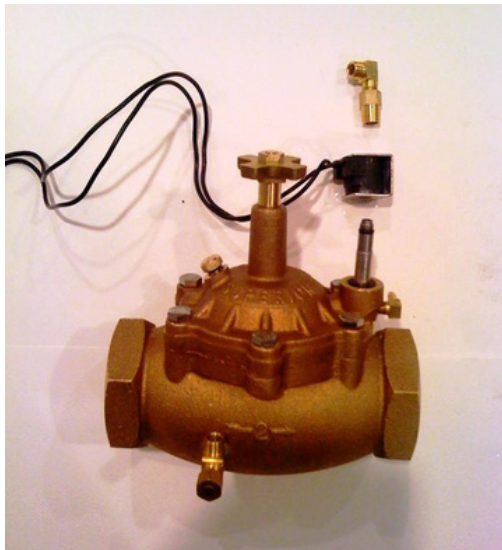
3. Slide solenoid coil and U-frame off of solenoid post.

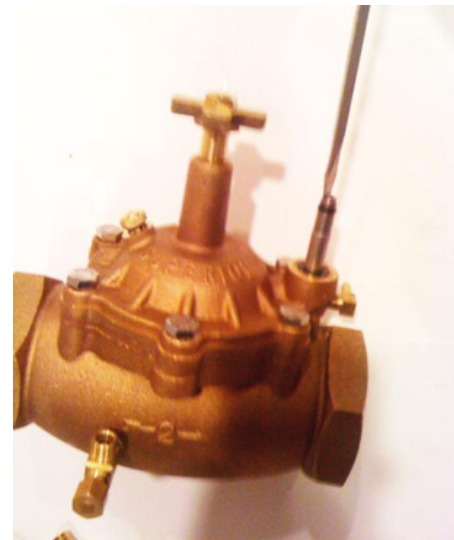
4. Using a flathead screwdriver, unscrew solenoid post from valve bonnet.

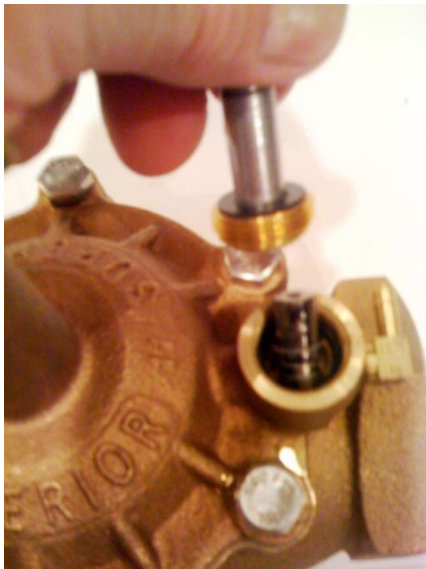
5. Take care as you remove the solenoid post as the plunger will drop out of the plunger tube as you lift the solenoid post.

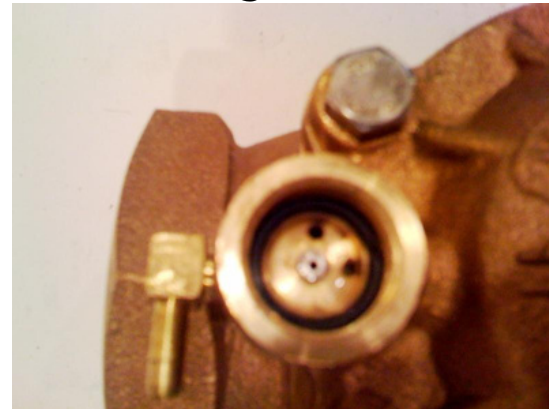
6. The photo shows the solenoid cavity of the model 3300. The port directly to the right of the exhaust port (center port) serves no function. The port directly above the exhaust port in this photo leads to the lower diaphragm chamber. The exhaust port leads to the barbed L-fitting where water in lower diaphragm chamber exhausts to atmosphere when solenoid is energized.

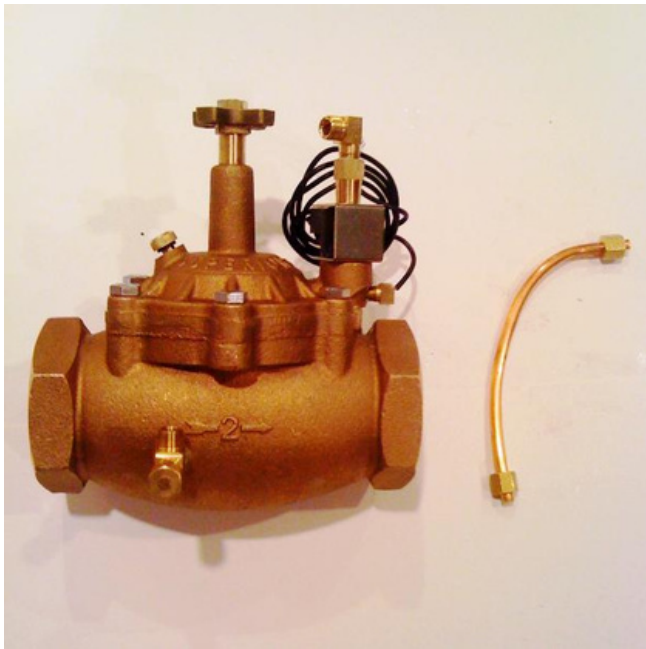
1. Using a $\frac{1}{2}$ " wrench, remove copper tubing that connects T-fitting assembly to L-fitting above solenoid.

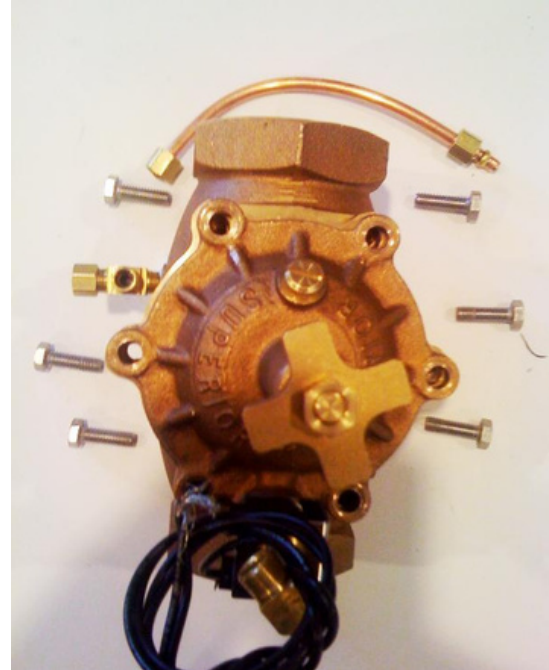
2. Remove bolts that fasten top to body and chamber-plate assembly.

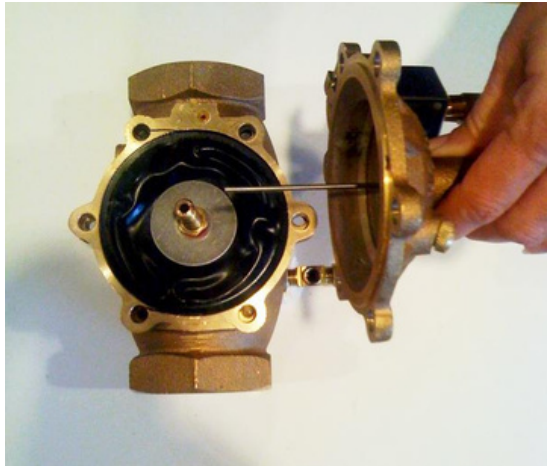
3. Lift top straight up and off of body and chamber- plate assembly taking care that metering rod clears the top of the diaphragm shaft.

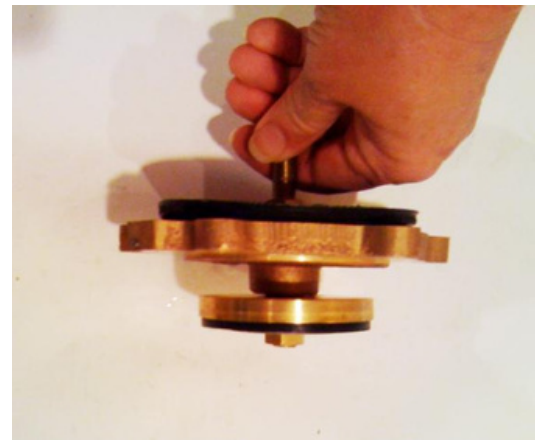
4. Remove chamber-plate assembly from valve body.

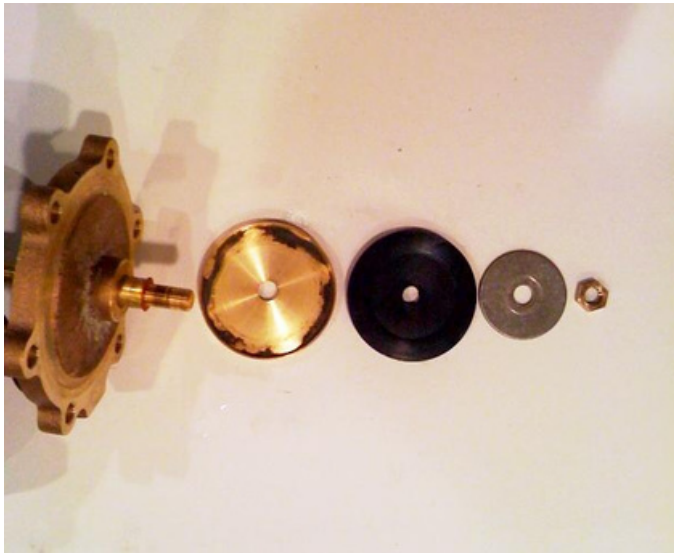
5. To remove rubber seat disc from chamber-plate assembly, use a 9/16" wrench to remove nut at bottom of diaphragm shaft and remove retaining washer, rubber seat disc, and disc holder.

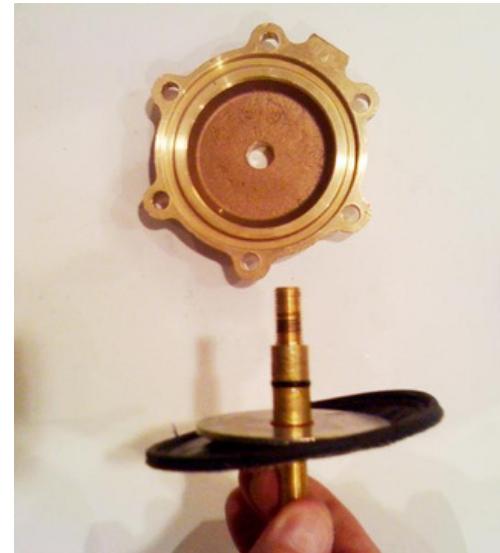
6. To access shaft o-ring, first follow step 5 instructions then remove diaphragm shaft from chamber-plate.

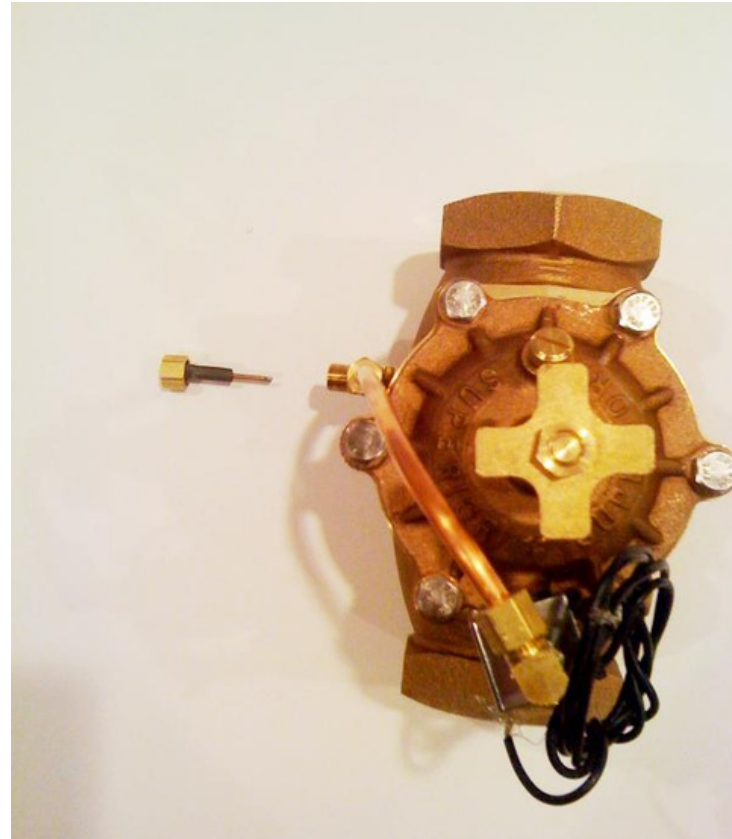
6. To remove T-filter from T-fitting, apply $\frac{1}{2}$ " wrench to cap and unscrew from T-fitting.

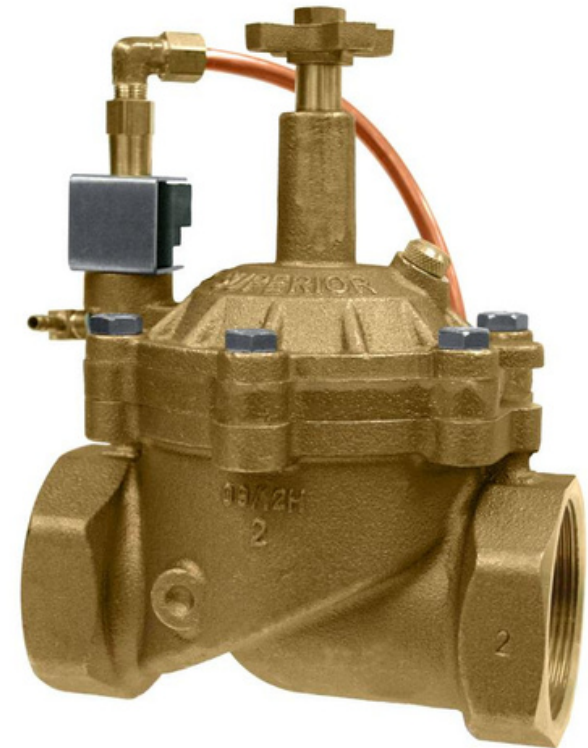
Valve will not close when controller energizes master valve circuit.

Solenoid coil is not energized. Place your fingers around the solenoid coil. If the coil is receiving power, you will feel a vibration. If not, problem is due to one of the following: 1) No output from controller, 2) broken or disconnected wire, or 3) bad solenoid coil.

With a volt meter, check output at controller. There should be 24 VAC output. If output is verified, then separate solenoid lead wires from valve wires (may need to cut wires) and with an ohm meter, conduct an ohm reading. If reading is between 24 and 27 ohms, the coil is good. If the reading is zero or infinity, replace coil. If the coil is OK then the problem is a broken or disconnected wire between the controller and solenoid coil.

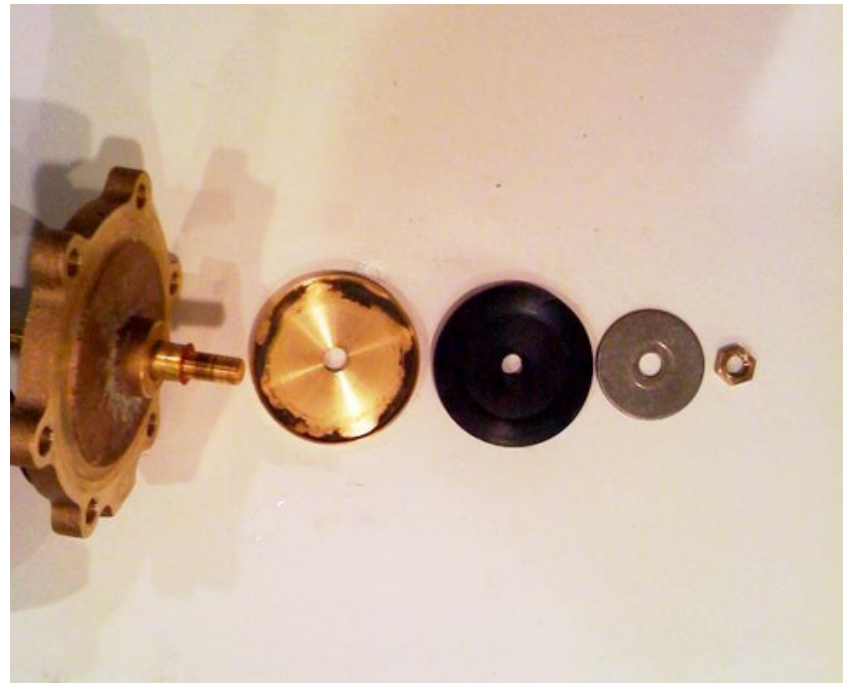
Valve will not close when solenoid is energized.

Debris in valve body or embedded in rubber seat disc.

Remove bonnet and chamber-plate assembly from valve body. Remove debris from valve body or seat disc. If seat disc is damaged, replace chamber-plate assembly or disassemble seat from diaphragm shaft and flip seat disc or replace if necessary.

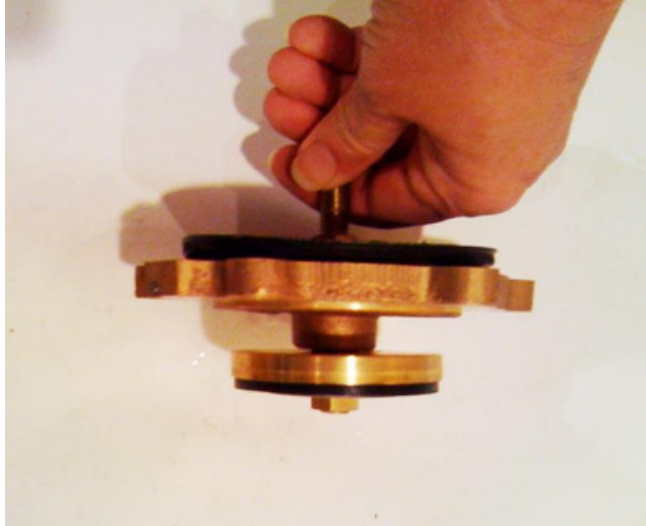
PROBLEM: Valve will not close when energized and water exhausts continuously from the barbed L-fitting (but stops when solenoid is de-energized).

Torn diaphragm.

Replace chamber-plate assembly.

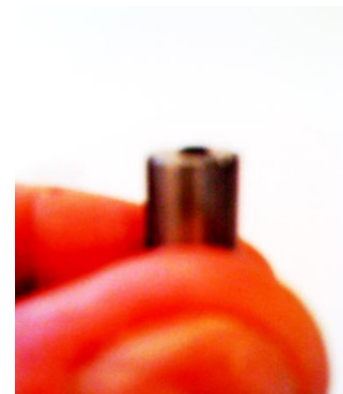
Solenoid plunger is not sealing 3/16" port at top of plunger tube. This could be due to debris in plunger tube, or rubber seat on top side of plunger which is spring loaded) is stuck below top surface of plunger. It should protrude about 1/32" above top surface.

Disassemble solenoid and check and clean plunger tube. If seat on top of plunger appears to be stuck below top surface, attempt to dislodge with paper clip. If necessary, replace plunger.

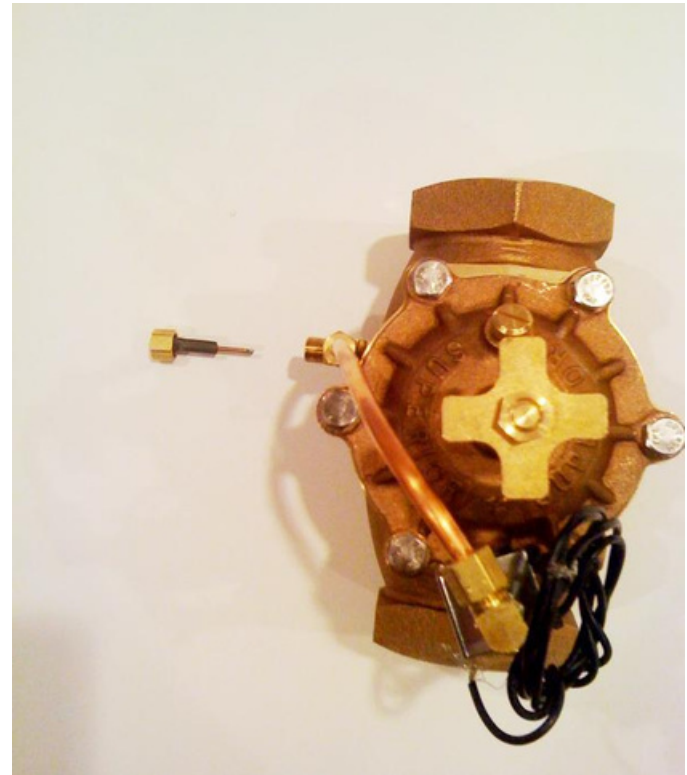
Valve remains closed when solenoid is not energized.

Water is not flowing through copper tubing to solenoid. To verify, while valve is pressurized, use a ½" wrench to loosen compression fitting that connects copper tubing to L-fitting above solenoid. If no water exhausts out around loosened compression fitting, diagnosis is confirmed.

Unscrew and remove T-filter from T-fitting. Clean filter and metering rod or replace T-filter assembly if necessary.

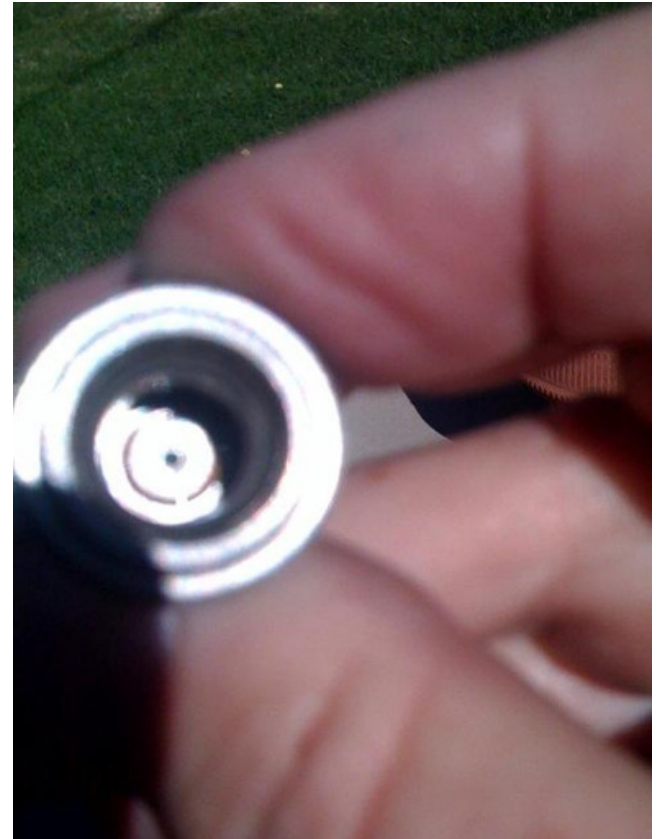
Valve remains closed when solenoid is not energized.

Malfunctioning solenoid. Either port at top of solenoid plunger tube is clogged or mineral buildup in solenoid tube is preventing water from entering lower diaphragm chamber. To verify, while valve is pressurized, loosen compression fitting that connects copper tubing to L-fitting above solenoid. If water exhausts out around the compression fitting, diagnosis is confirmed.

Disassemble solenoid. If 3/16" port at top of plunger tube is clogged, use a sharp object like a paper clip to unclog port. If mineral buildup or corrosion is evident in plunger tube, replace stem and plunger assembly.

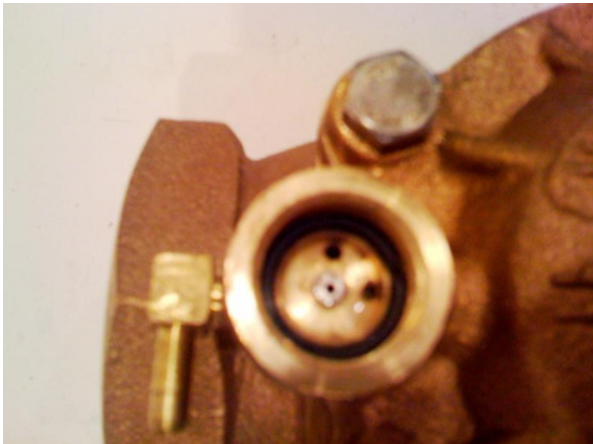
Valve remains closed when solenoid is not energized and water continuously flows out of barbed L-fitting below solenoid.

Debris in solenoid cavity is preventing solenoid plunger from sealing exhaust port.

Disassemble solenoid and remove debris from solenoid cavity.

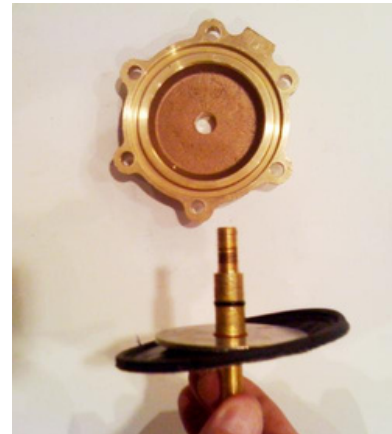
Valve does not fully open when solenoid is not energized.

Damaged o-ring on shaft of chamber-plate assembly.

Replace chamber-plate assembly, or remove damaged o-ring from diaphragm shaft and replace with new o-ring. Apply silicone grease to o-ring before re-assembling to chamber-plate.
