SUPERIOR

Model 3100

Disassembly Instructions and
Troubleshooting
(Applies to Model 3100PRS)

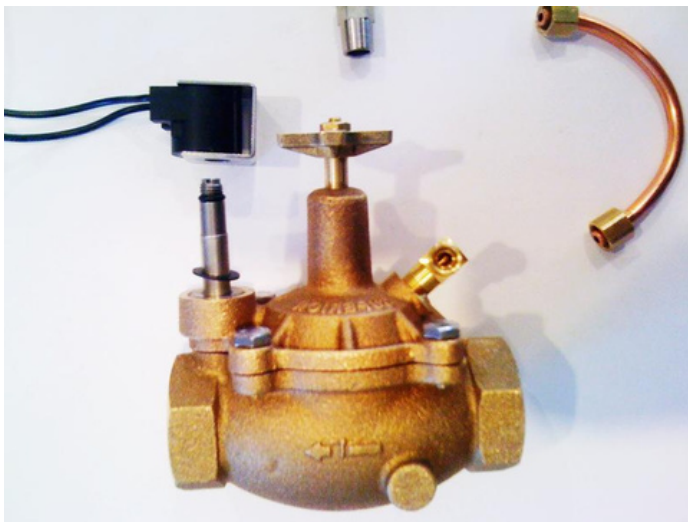
3. Slide coil and U-frame off of solenoid post.

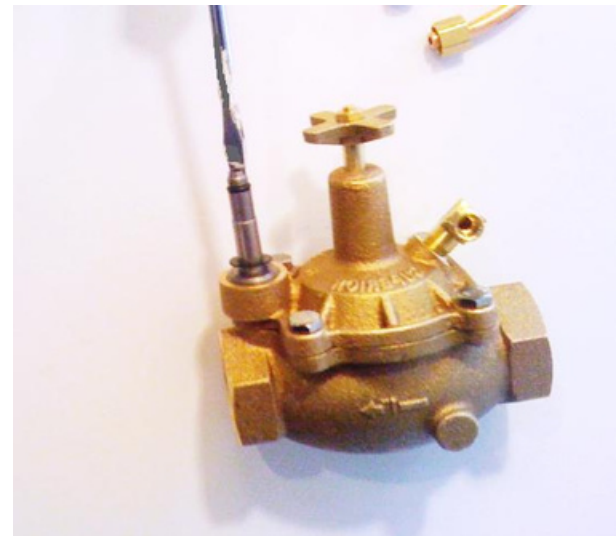
4. Using a flathead screwdriver, remove post from top of valve.

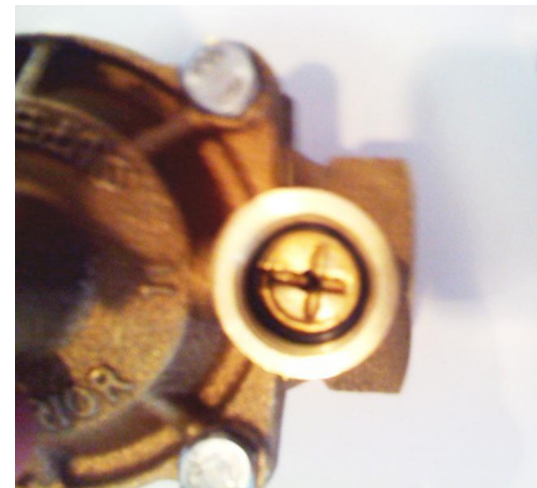
6. After removing the solenoid plunger, all that has a cross machined in it so water will be able to escape downstream when the solenoid is not energized and valve will remain open. remains is the o-ring at the bottom. Note that seat

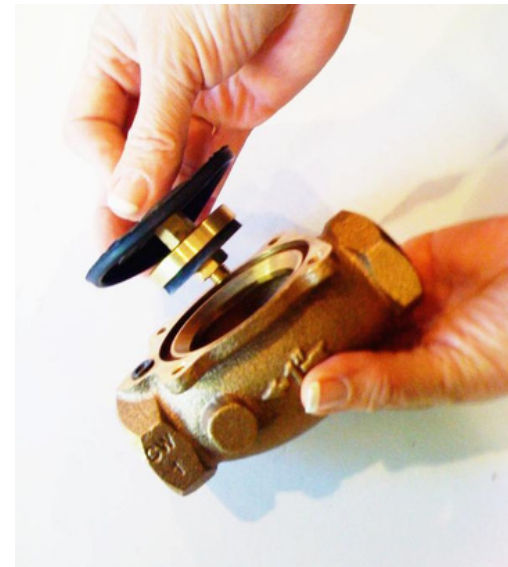
4. Remove diaphragm assembly from valve body.

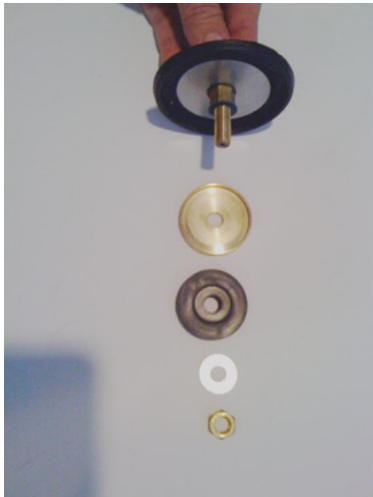
5. To remove rubber seat disc from diaphragm assembly, unscrew nut at bottom of diaphragm assembly.

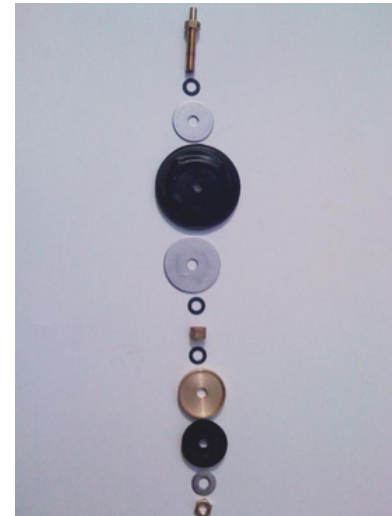
6. Completely disassembled diaphragm assembly. From top to bottom: Diaphragm shaft, fiber washer, upper diaphragm plate, diaphragm, lower diaphragm plate, fiber washer, spacer nut, fiber washer, seat disc holder, seat disc, retaining washer, and seat disc nut.

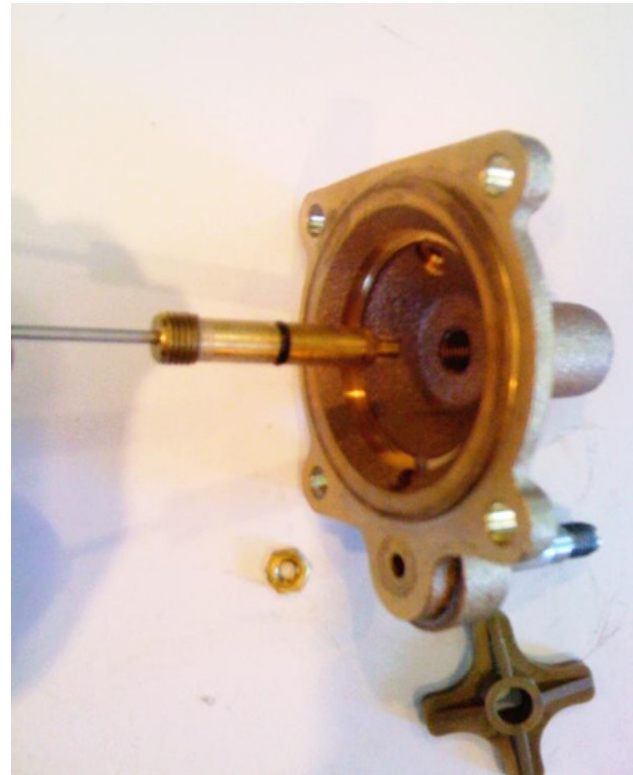
7. To remove flow control stem from bonnet, remove nut and cross-handle from top of stem, then unscrew flow control stem from underside of bonnet.

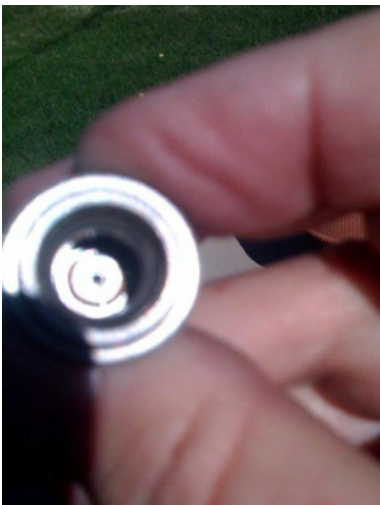
PROBLEM: Valve will not close when energized.

Debris in plunger tube is preventing plunger from sealing port at top of plunger tube.

Clean plunger tube or replace if necessary.

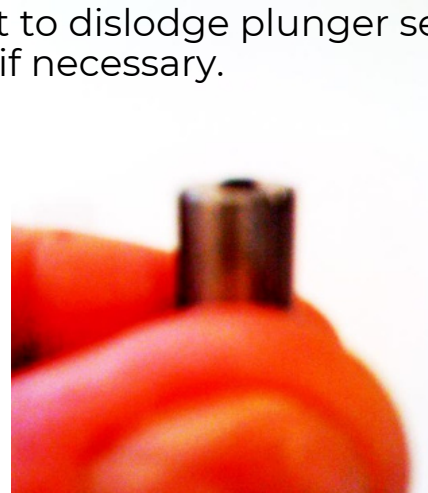
Plunger seat on top side of solenoid plunger is retracted below surface of plunger top. The rubber seat has a spring under it in an opening in the top of the plunger that allows the seat to move up and down. It is possible for the plunger to get stuck below the surface of the plunger top.

Attempt to dislodge plunger seat or replace if necessary.

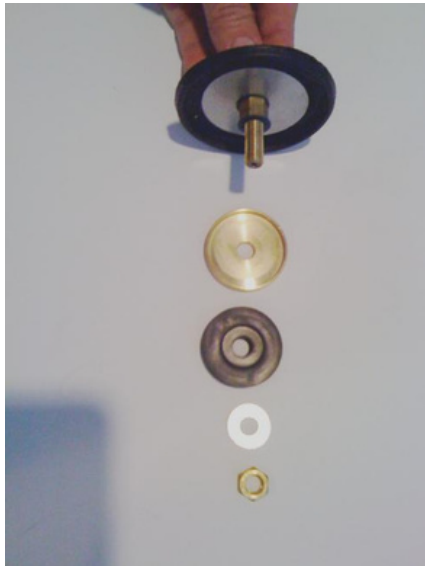
PROBLEM: Valve will not close when energized.

Debris under rubber seat disc is preventing it from seating onto brass seat in valve body.

Remove diaphragm assembly, check and remove debris in body or in rubber seat disc. If rubber seat is pitted, flip it over or replace it.

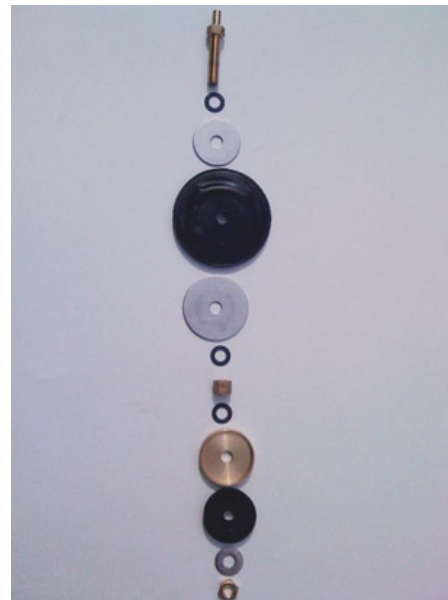
Torn diaphragm.

Disassemble diaphragm assembly and replace diaphragm or replace diaphragm assembly.

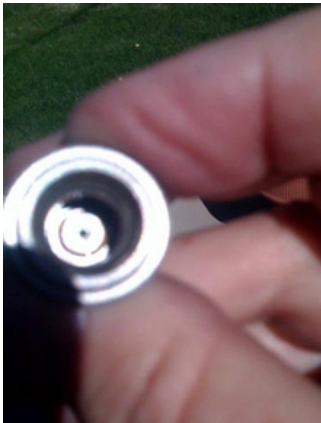
Valve closes or partially closes when solenoid is not energized.

Inlet orifice at top of solenoid plunger tube is clogged, or corrosion in solenoid plunger tube is preventing water from escaping at the rate required to keep the valve fully open.

If port is clogged, clean it with small sharp object such as a paper clip. If corrosion is evident, replace stem and plunger assembly.

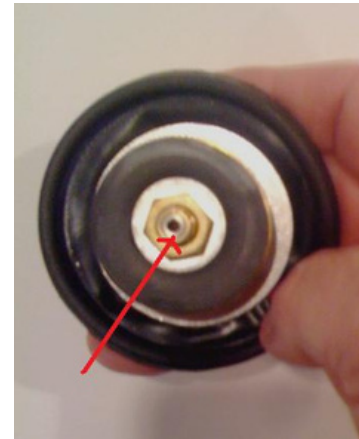
Valve remains closed when solenoid is not energized.

Water is entering upper diaphragm chamber at too great of a rate due to: 1) Stainless steel inlet orifice in bottom of diaphragm shaft has fallen out, or 2) metering rod in flow control stem has fallen out.

If the stainless steel inlet orifice is missing, replace diaphragm shaft or diaphragm assembly. If metering rod is missing, replace flow control stem.

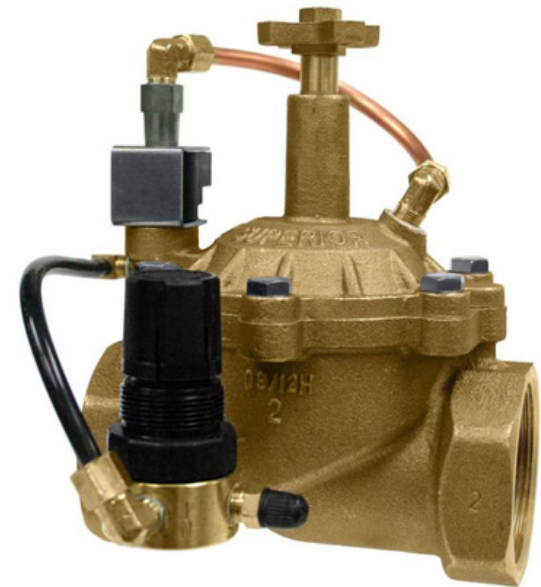
Valve remains closed when solenoid is not energized.

Adjustment knob on regulator is in “off” position preventing water from passing thru regulator.

Raise knob on regulator to unlock it, then rotate knob clockwise, a half turn at a time, until water begins to pass thru valve. Wait until system is fully pressurized then continue to rotate knob clockwise until desired setting is reached. Next, push down on regulator knob to lock it in place.

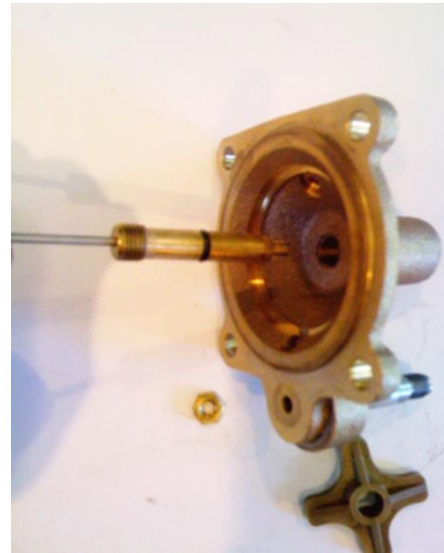
Water is leaking out around flow control stem.

O-ring on flow control stem is damaged.

Disassemble flow control stem from bonnet and replace o-ring. Before reassembling stem to bonnet, apply silicone grease to o-ring.
