SUPERIOR Model 3200 Disassembly instructions and Troubleshooting

Index

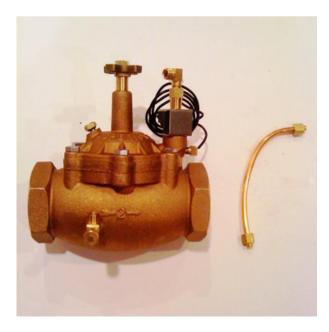
1. Remove copper tubing that connects T-filter assembly to L-fitting above solenoid

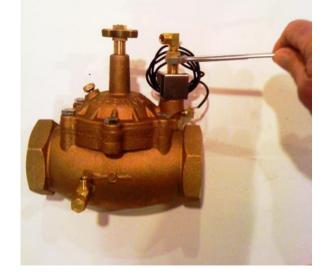
2. Apply ½" wrench to hex portion of coupling that connects solenoid post to L-fitting and unscrew coupling and L-fitting from solenoid post. It is not necessary to separate L-fitting from coupling.

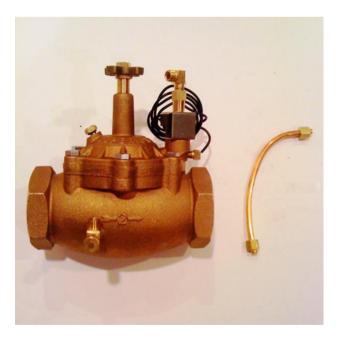
1. Using a ¹/₂" wrench, remove copper tubing that connects T-filter assembly to L-fitting above solenoid.

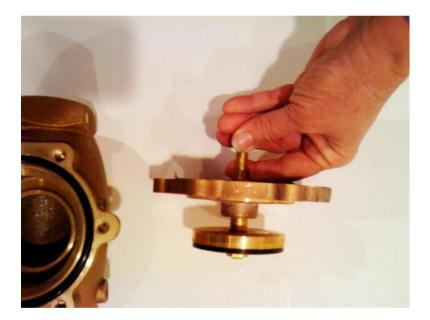
4. Photo of valve body, chamber-plate assembly and bonnet.

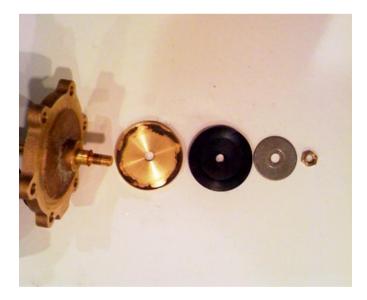
5. To replace rubber seat disc, unscrew retaining nut from bottom of diaphragm shaft then remove retaining washer, rubber seat disc, and disc holder.

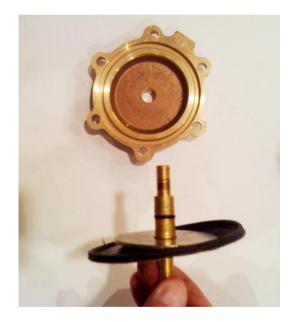
6. To gain access to shaft o-ring, remove diaphragm shaft from chamber-plate after the seat disc and disc holder have been removed from bottom of shaft.

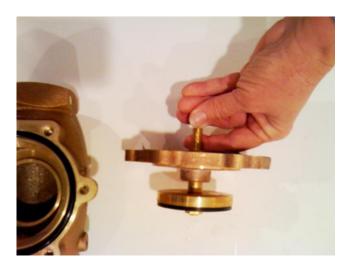
Valve will not close and water constantly exhausts from vent hole in chamber-plate (located on rear side of valve).

Torn diaphragm.

Replace chamber plate assembly.

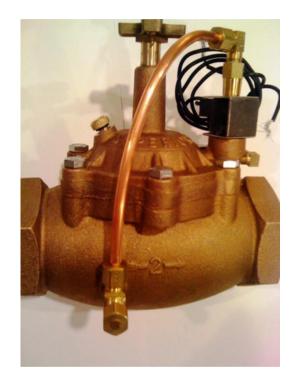
Solenoid coil is not energized. Place your fingers around the solenoid coil. If the coil is receiving power, you will feel a vibration. If not, problem is due to one of the following: 1) No output from controller, 2) broken or disconnected wire, or 3) bad solenoid coil.

With a volt meter, check output at controller. There should be 24 VAC output. If output is verified, then separate solenoid lead wires from valve wires (may need to cut wires) and with an Ohm meter, conduct an Ohm reading. If reading is between 24 and 27 Ohms, the coil is good. If the reading is zero or infinity, replace coil. If the coil is OK then the problem is a broken or

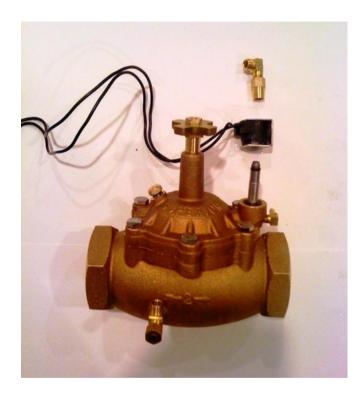
Mineral buildup on solenoid plunger or corrosion in plunger tube is preventing plunger from lifting when solenoid is energized.

Replace solenoid stem and plunger assembly.
