# Model 3200 Disassembly instructions and Troubleshooting

#### Index

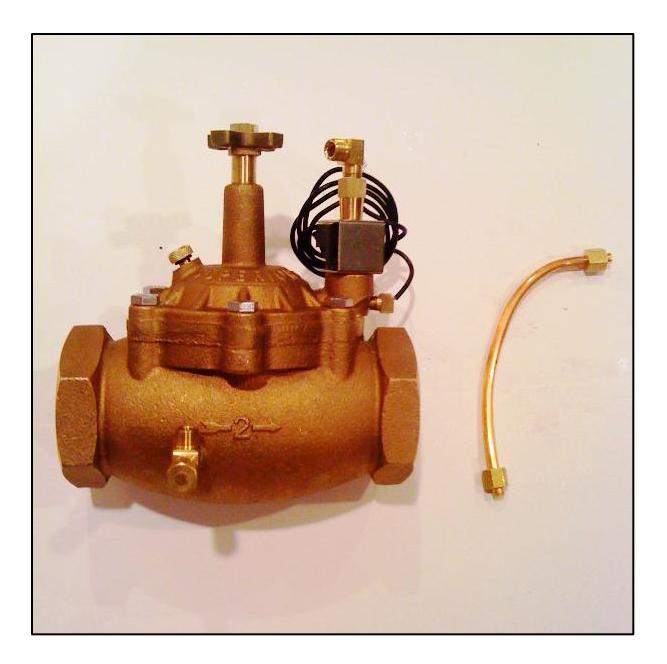
**1.** Remove copper tubing that connects T-filter assembly to L-fitting above solenoid

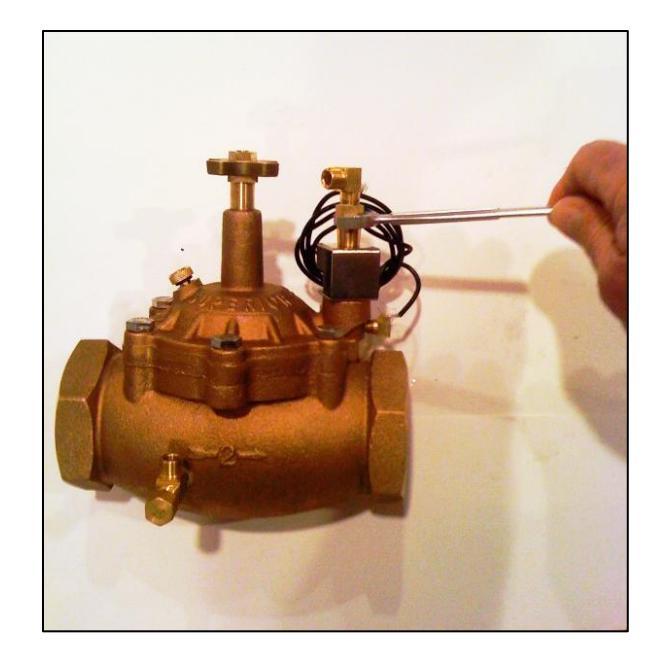
2. Apply ½" wrench to hex portion of coupling that connects solenoid post to L-fitting and unscrew coupling and L-fitting from solenoid post. It is not necessary to separate L-fitting from coupling.

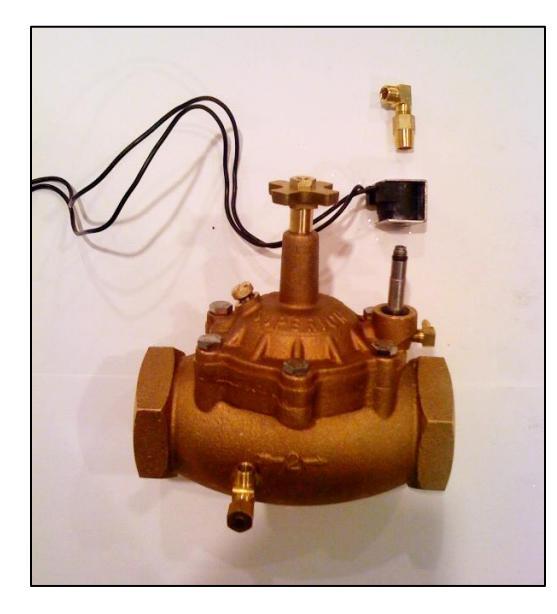
**3.** After removing coupling and L-fitting, slide solenoid coil and U-frame off of solenoid post.

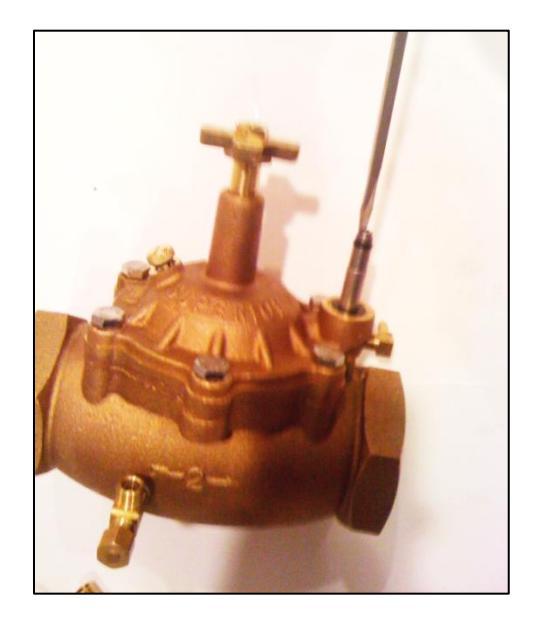
**4.** Using a flathead screwdriver, unscrew solenoid post from bonnet.

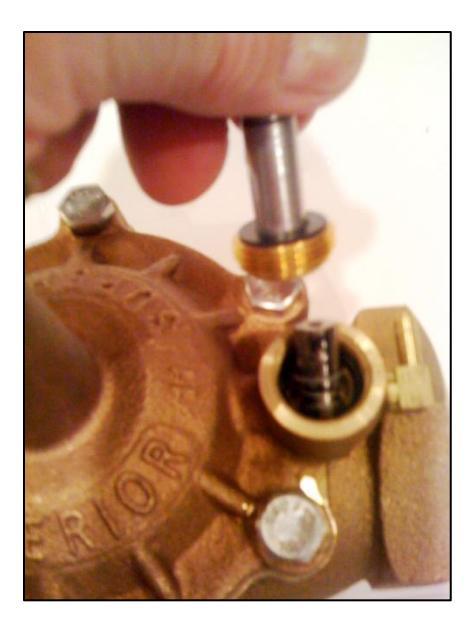
**5.** Take care as you remove solenoid post as the plunger will drop out of the plunger tube into solenoid cavity.

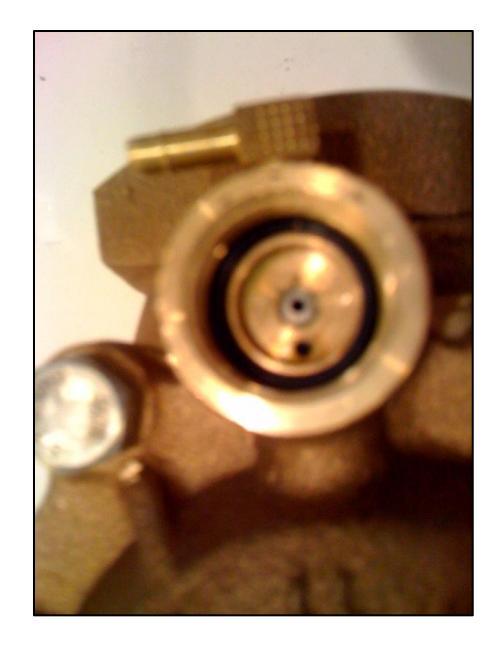
**6.** Photo of solenoid cavity. The o-ring seal can be seen at bottom of cavity. The port in the center of the cavity is the exhaust port. The other port connects the diaphragm chamber to the solenoid chamber.

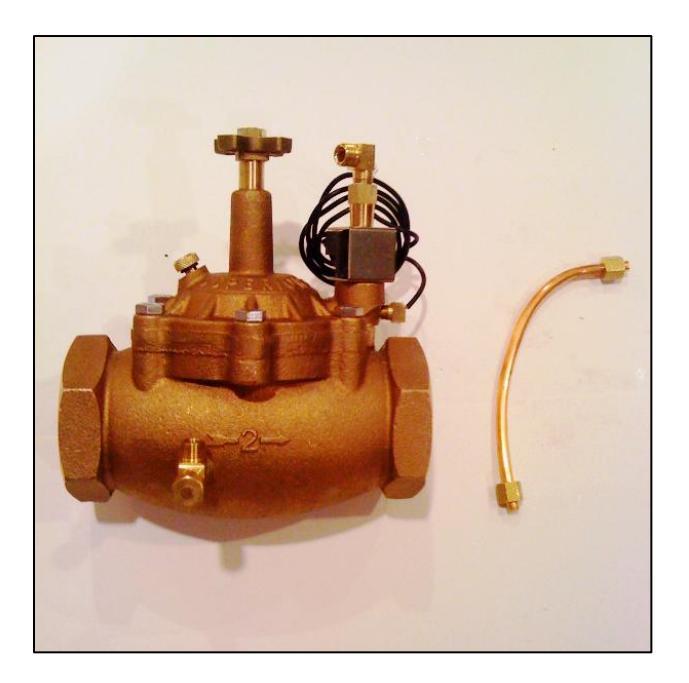
**1.** Using a ½" wrench, remove copper tubing that connects T-filter assembly to L-fitting above solenoid.

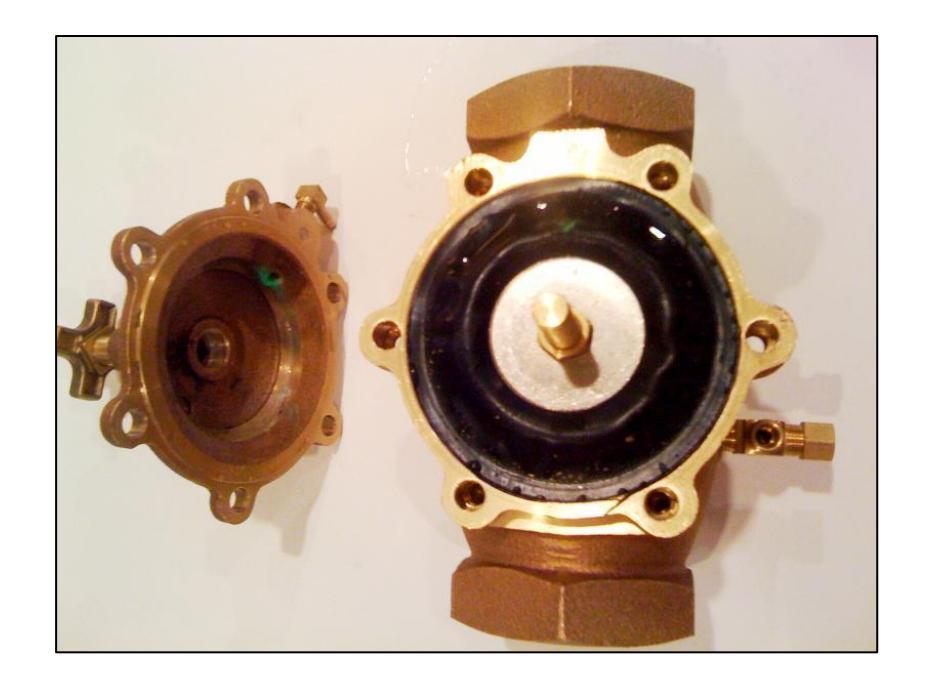
**2.** Unscrew top bolts and lift and remove bonnet from rest of valve.

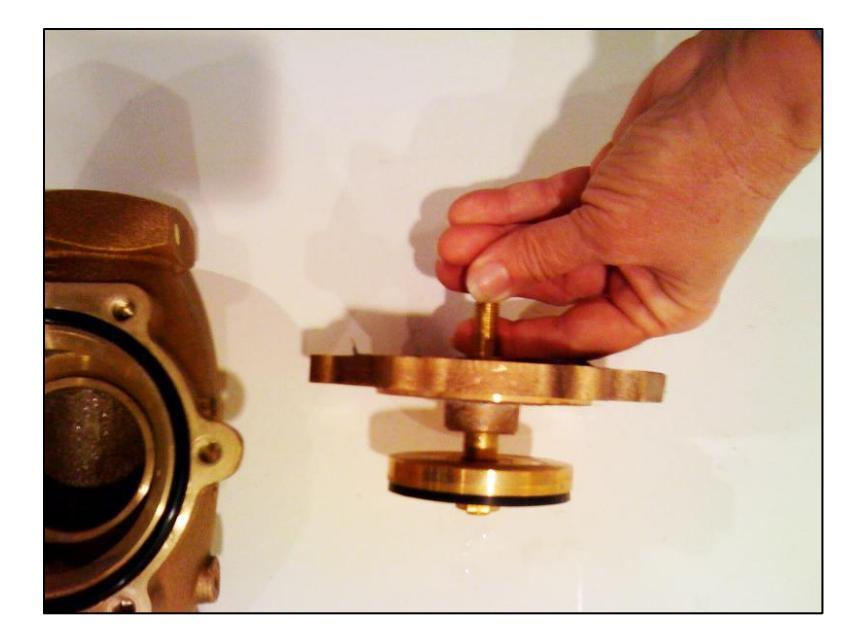
**3.** Remove chamber-plate assembly from valve body.

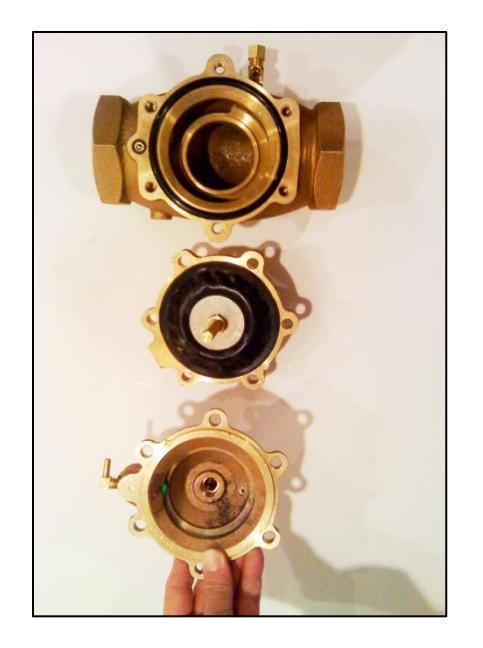
**4.** Photo of valve body, chamber-plate assembly and bonnet.

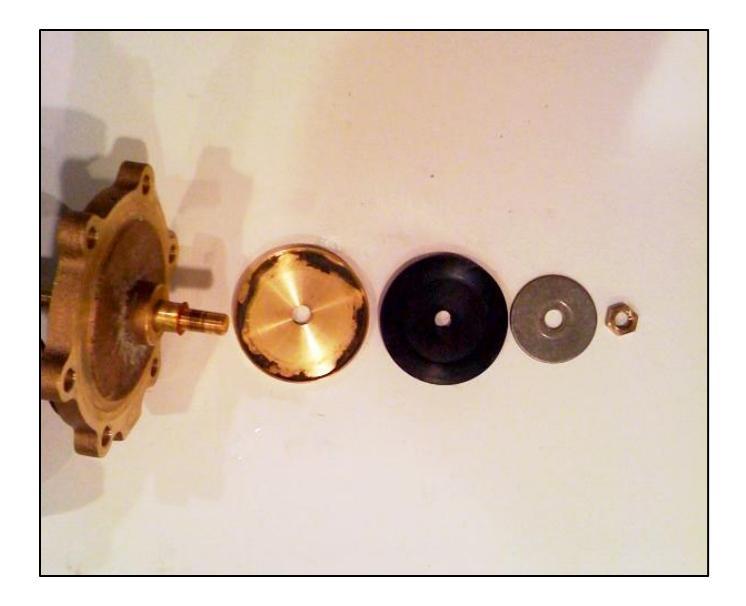
**5.** To replace rubber seat disc, unscrew retaining nut from bottom of diaphragm shaft then remove retaining washer, rubber seat disc, and disc holder.

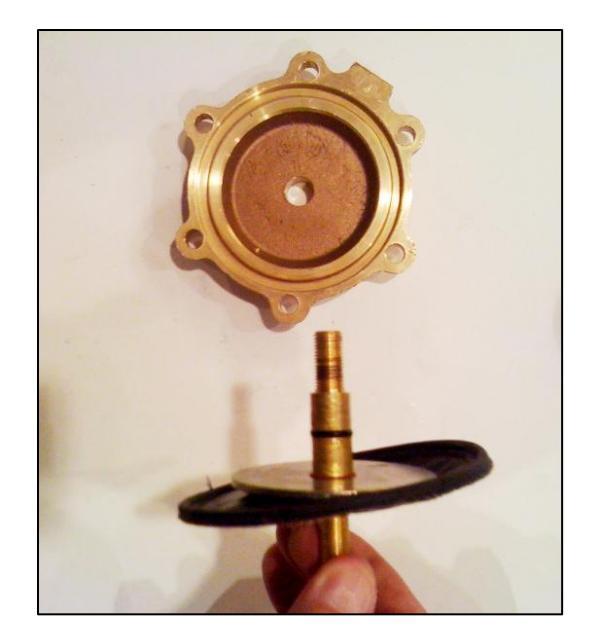
**6.** To gain access to shaft o-ring, remove diaphragm shaft from chamber-plate after the seat disc and disc holder have been removed from bottom of shaft.

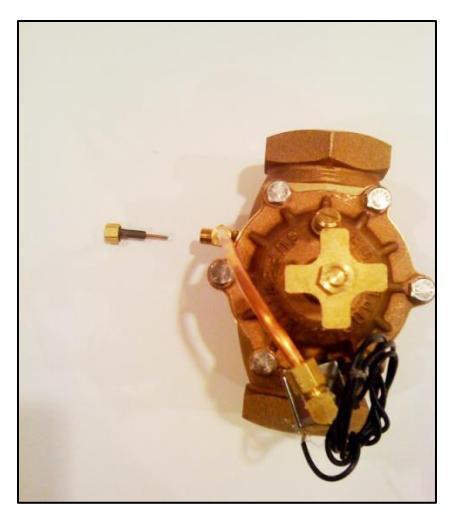
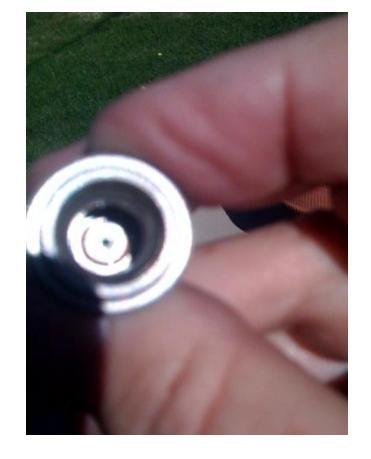
**CAUSE #1:** Water is not flowing though copper tubing so no water is able to enter upper diaphragm chamber. To verify, loosen compression fitting that connects tubing to L-fitting above solenoid. If no water exhausts from loose fitting, then diagnosis is confirmed.

**SOLUTION:** Shut off water supply to valve, then unscrew and remove T-filter from T-fitting. Clean filter and metering rod or replace T-filter if necessary.

**CAUSE #2:** Malfunctioning solenoid. Either the port at top of plunger tube is clogged, or plunger is stuck in plunger tube and will not drop when solenoid is de-energized.

**SOLUTION:** Disassemble solenoid. If plunger is not stuck in plunger tube, clean port at top of plunger tube with sharp object like a paper clip. If plunger is stuck in plunger tube, attempt to dislodge and clean tube and plunger. Replace stem and plunger assembly if necessary.

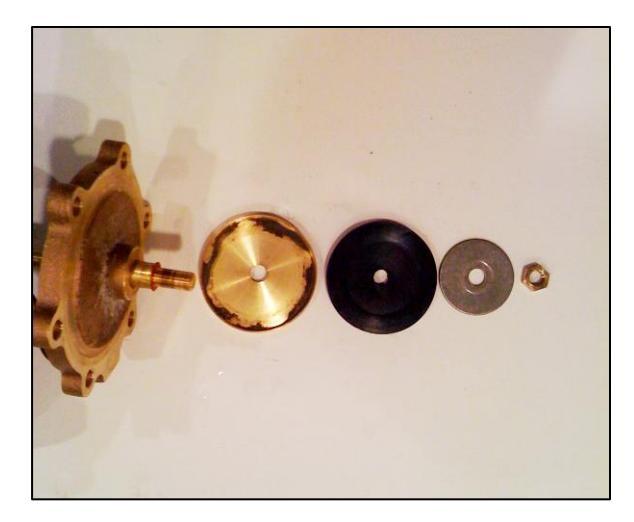
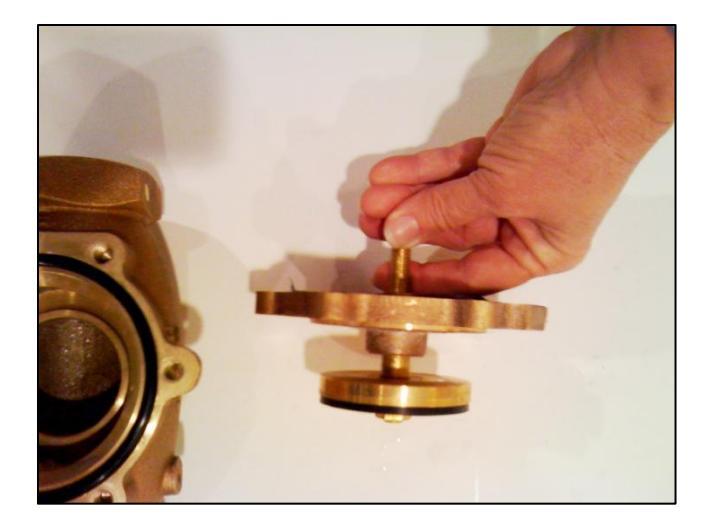
**CAUSE #3:** Debris in body of valve or embedded in rubber seat disc.

**SOLUTION:** Remove bonnet and chamber-plate assembly from valve body. Remove debris from valve body or seat disc. If seat disc is damaged, replace chamber plate assembly or disassemble seat from diaphragm shaft and flip seat disc or replace if necessary. **PROBLEM:** Valve will not close and water constantly exhausts from vent hole in chamber-plate (located on rear side of valve).

**CAUSE:** Torn diaphragm.

SOLUTION: Replace chamber plate assembly.

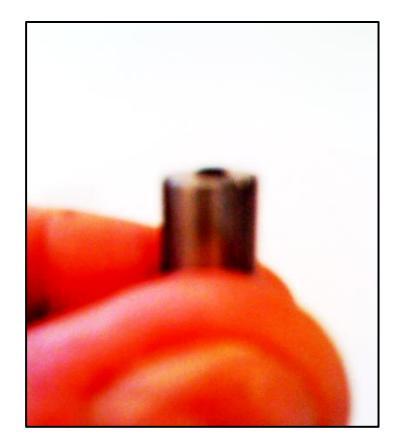
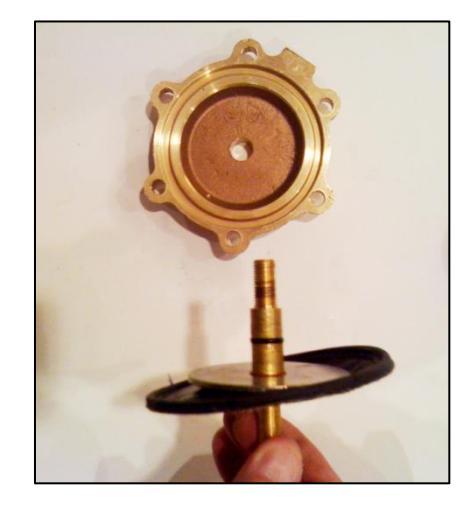
**CAUSE:** Solenoid plunger is not sealing 3/16" port at top of plunger tube. This could be due to debris in plunger tube, or the rubber seat on top side of plunger (which is spring loaded) is stuck below the top surface of plunger. It should protrude about 1/32" above the top surface.

**SOLUTION:** Disassemble solenoid and check and clean plunger tube as necessary. If seat on top of plunger appears to be stuck below top surface, attempt to dislodge with paper clip or wire. If necessary, replace plunger.

**CAUSE:** Damaged shaft o-ring.

**SOLUTION:** Replace chamber-plate assembly, or remove damaged o-ring from diaphragm shaft and replace with a new o-ring. Apply silicone grease to o-ring before re-assembling chamber plate assembly.

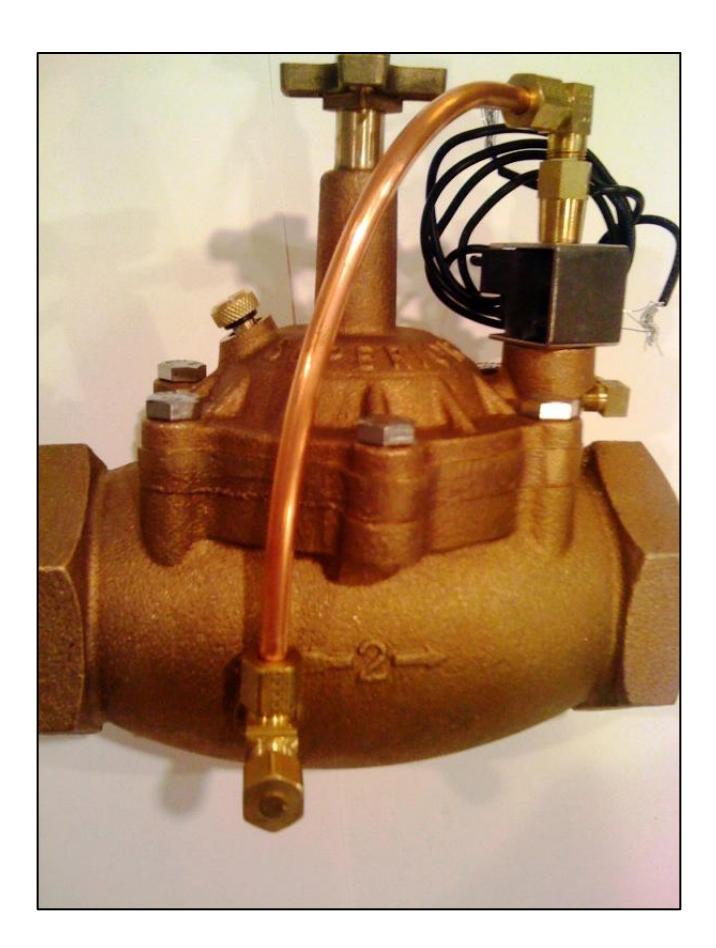
**CAUSE #1:** Solenoid coil is not energized. Place your fingers around the solenoid coil. If the coil is receiving power, you will feel a vibration. If not, problem is due to one of the following: 1) No output from controller, 2) broken or disconnected wire, or 3) bad solenoid coil.

**SOLUTION:** With a volt meter, check output at controller. There should be 24 VAC output. If output is verified, then separate solenoid lead wires from valve wires (may need to cut wires) and with an Ohm meter, conduct an Ohm reading. If reading is between 24 and 27 Ohms, the coil is good. If the reading is zero or infinity, replace coil.

If the coil is OK then the problem is a broken or disconnected wire between the controller and solenoid coil.

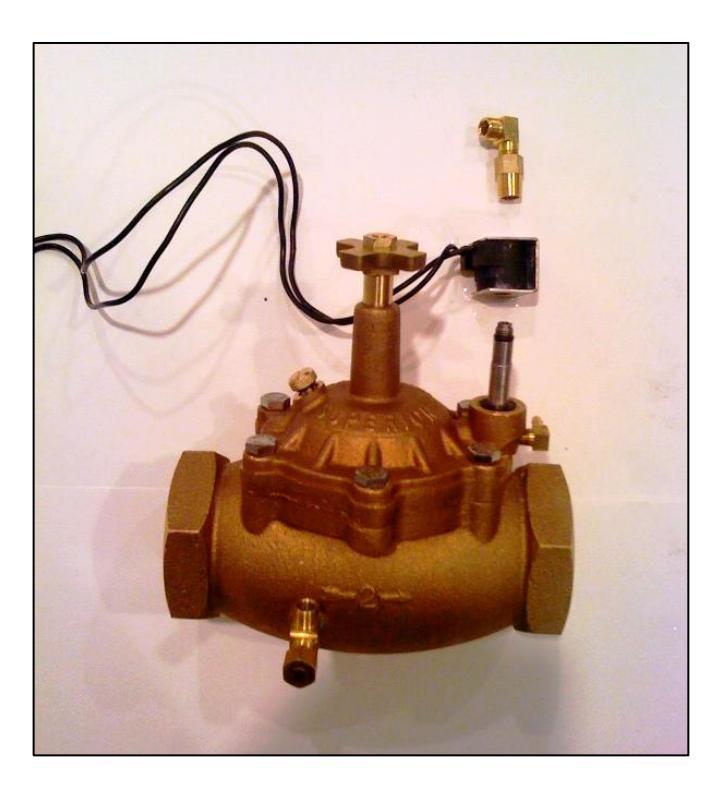
**CAUSE #2:** Mineral buildup on solenoid plunger or corrosion in plunger tube is preventing plunger from lifting when solenoid is energized.

**SOLUTION:** Replace solenoid stem and plunger assembly.
